Injury to head due to
fall from Ladder

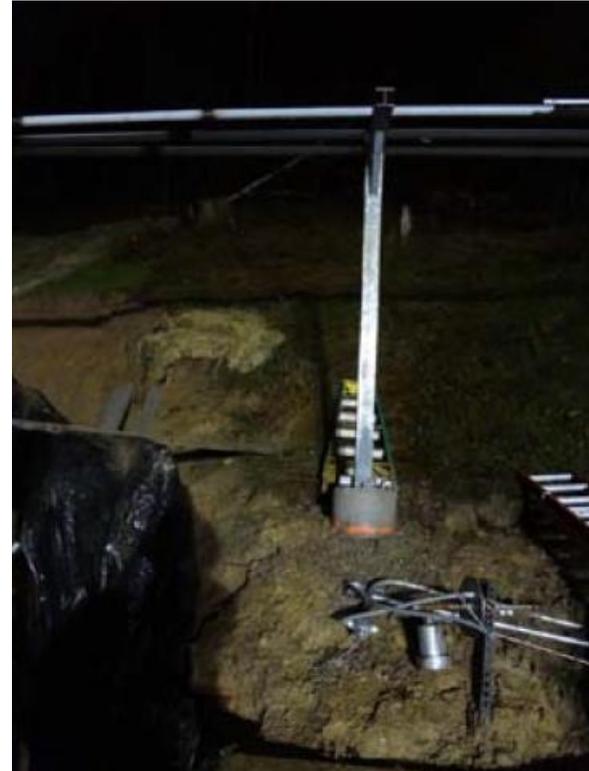
- The injured employee was ascending the ladder and was handed the camera at about half the distance to the working elevation. When the injured employee reached the working elevation, grabbed the camera with both hands at his left side and attempted to heft the camera onto the wood platform. This sudden weight shift caused the ladder to push back and to break away from its footing.
- As the ladder fell the injured employee attempted to grab onto the piping. The injured employee slipped and fell from the piping landing head first on unknown object(s) causing injuries to his head.
- The injured employee was transported by private vehicle to the hospital for treatment and was diagnosed with multiple subdural hematomas and a fracture of the skull. No other injuries were incurred.
- The location at the worksite where the accident happened is shown in the picture.

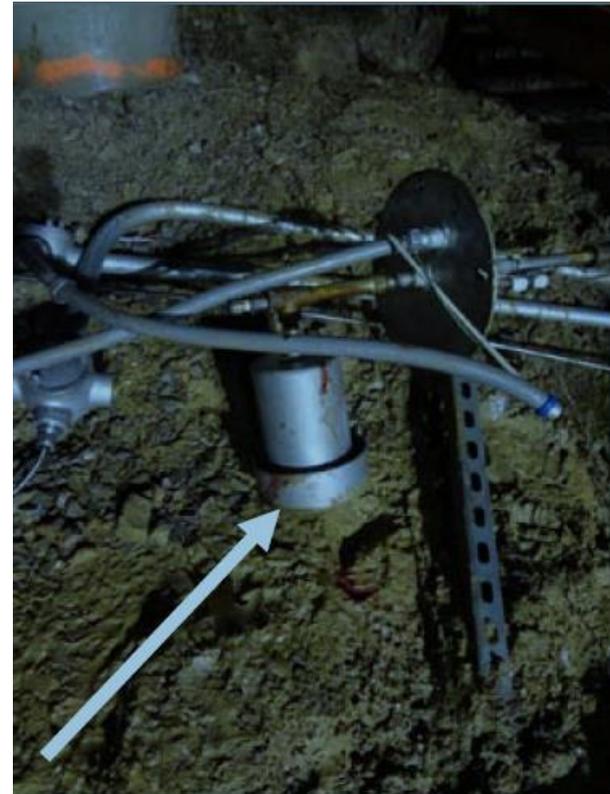
- There was a great deal of equipment and supplies in the work area, which made it difficult to properly utilize the boom lift without difficulty.
- The ladder used as a work platform had not been tied off at any point of the ladder.
- A sudden shift in weight appears to be the factor that caused the slippage of the ladder.
- The injured employee's feet were approximately 6 feet (1.8 meters) above the ground prior to the fall.
- The object that was hit by the injured person's head is shown in the picture.
