Dropped Scaffold Toe board resulted with injury

Location/Site: CS5/Phase-1 Compressor 2

Title: Dropped Scaffold Toe board

Date	04.02.2019
Event Type	Medical Treatment Case

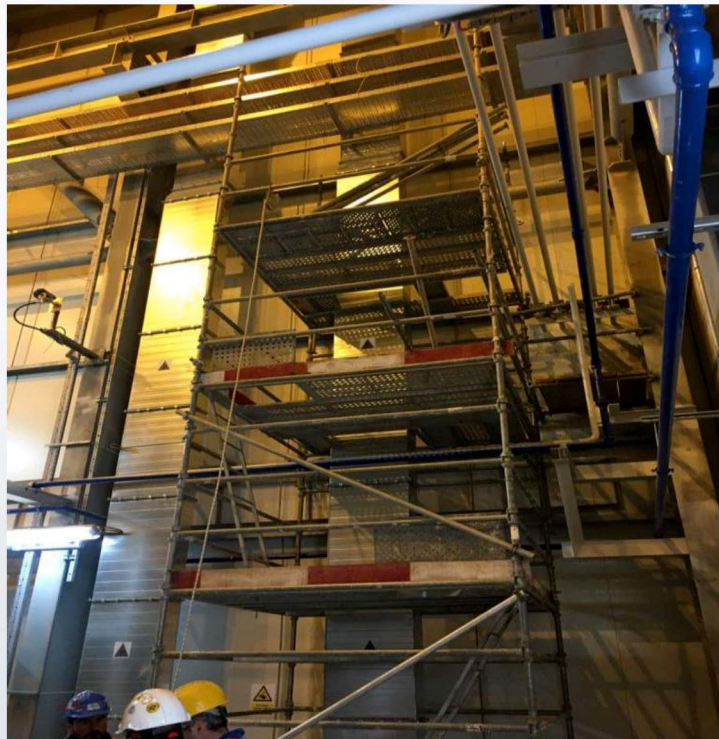
Brief Description	During the dismantling of the scaffolding inside the compressor building, a piece of scaffold toeboard was dropped from 2.5 meters height and hit the face of the worker standing for dismantling.
Immediate actions	Area was secured. After the first medical intervention was applied at the site, the person was transferred to State Hospital. Three stitches applied on the impact area of the worker's face.
Root causes / Counter-measure- LLD	<p>Root Causes:</p> <ul style="list-style-type: none"> • Behaviors : Inadequate identification of critical safe behaviors. Personnel was not aware that being inside the line of fire. • Management / Supervision / Employee Leadership: Inadequate correction of prior hazard / incident. (Similar incidents were happened at site previously but it seems that lessons learned not embedded) • Training / Transfer Knowledge: Inadequate recall of training material, training not reinforced on the job. (Specific trainings were well transferred to personnel, but he did not reinforce on the job.) <p>Counter measures:</p> <ul style="list-style-type: none"> • Scaffold erection and dismantling works risk assessment revised and related training conducted for scaffolding team. • Line of fire trainings delivered to the scaffolding team. <p>Key Learning:</p> <ul style="list-style-type: none"> • Be alert and learn to recognize Line of Fire at work. • Ensure that LLD shared in effective way among all personnel to prevent reoccurrence.
