<b>Title:</b>	Snapped wire cable of piling rig	<b>Synergi Case N°.</b>	417795
<b>Region/ Project:</b>	Region A – PPF6 New Finishing	<b>Incident Date:</b>	19/10/2015
<b>HSE Alert Category:</b> <i>(Synergi Incident Categorisation)</i>	Equipment (SIF Near Miss)	<b>Alert Issue Date:</b>	22/10/2015

## 1.0 DESCRIPTION OF THE INCIDENT

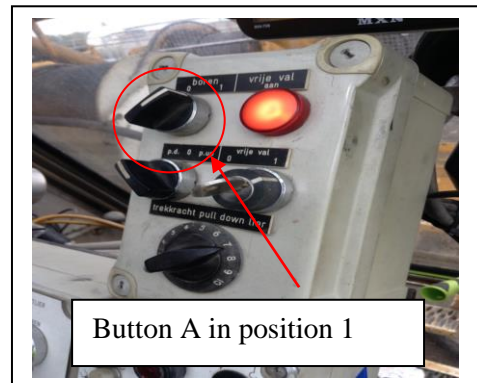
While operating the command to drill piles, the operator has to switch the button A in position 1. When the button A is in position 1, the operator can control by using the levers and the switches below for raising the drilling motor platform, pulling down the pile... The operator did not turn the switch completely to 1 as he was focusing on several people around the machine and also getting

As a consequence, the drum with the wire cable to raise the drilling motor platform was spinning as well as the drum with the wire cable to pull down the pile. The last one gets in tension until exceeding his maximal strength capacity and snapped.

Button A in position 1

- Check the possibility to install additional barrier on the switch control box to avoid simultaneous conflicting operation (pull up, pull down).
- Double check by the operator to verify after operating the switch button A in position 1 by slightly moving the levers and visually checks the wire cable drums.
- Re definition of the site coordination for piling works. One focal point nominated (other than the piling rig operator).
- Update of the Method Statement / JSA related to piling operations accordingly.
- Toolbox talk with the team to share the incident and corrective measures.

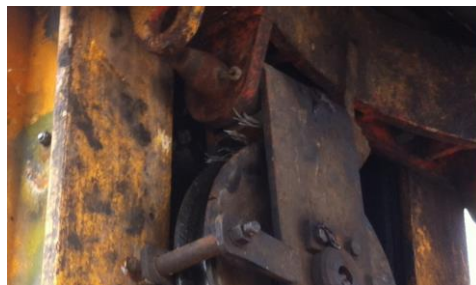
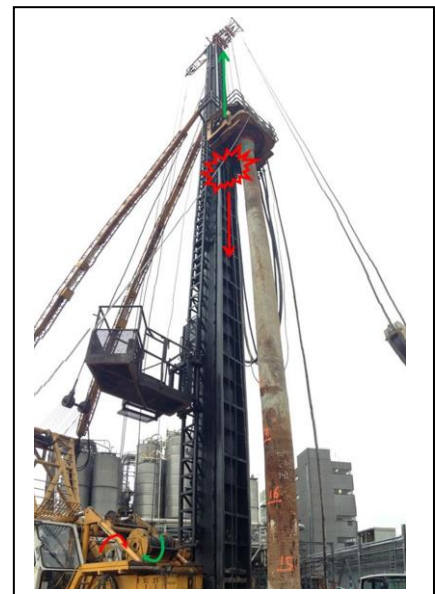
No injury/damage reported (wire cable snapped).

- Job suspended
- Review of the incident and start of the investigation process
- Repair of the damaged cable
