# Lesson Learned No-17

## AUTO IGNITION OF FOAM TRENCH BREAKERS

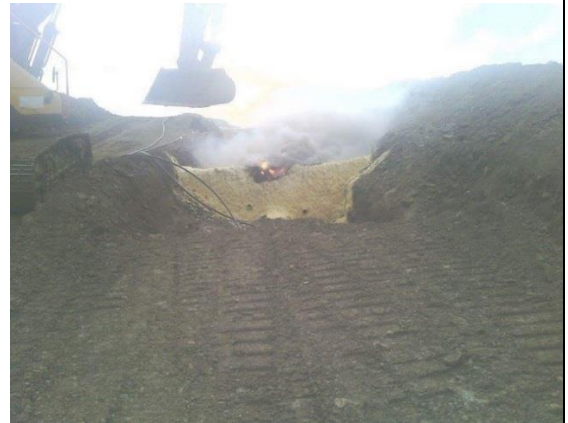
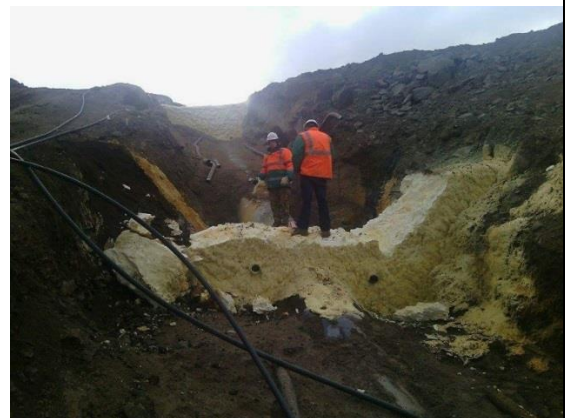
On 2 separate occasions foam trench breakers installed on the ROW (to prevent erosion and wash-out of the soil within the trench) have auto-ignited a number of hours after the foam had been dispensed.

The foam curing process involves an exothermic reaction. Due to the self-insulating properties of the foam, prolonged and continuous application on large sections can lead to extended curing times and increased core temperatures. This is typically mitigated by slow application of the sprayed foam allowing sufficient time between layers for the foam to cream and expand.

1. Cold temperature (0 to 1 degree Celsius) is a contributing factor, as the foam expansion is less than in normal conditions and the applicators have the tendency to use more material.
2. Spraying of the foam too fast, not following manufactures instructions on waiting times between applications.

- Lower ambient temperatures (1° to 4°C) on the days of application increased the curing times.
- Large volumes of foam were applied without allowing the foam to cream and commence curing.
- Revised relevant Work Instruction with corrected methodology
- Ensure all individuals who spray/apply the foam are suitably trained (or refreshed) in relation to the correct application methodology
