HSE Safety Alert

U.S. Pipeline, Inc.

Date:	February 04, 2015
Situation:	Medical Recordable / Grinder Brush Incident
Notification to:	All USPL Employees

Employee Hand Contacted By Grinding Brush Resulting In Laceration

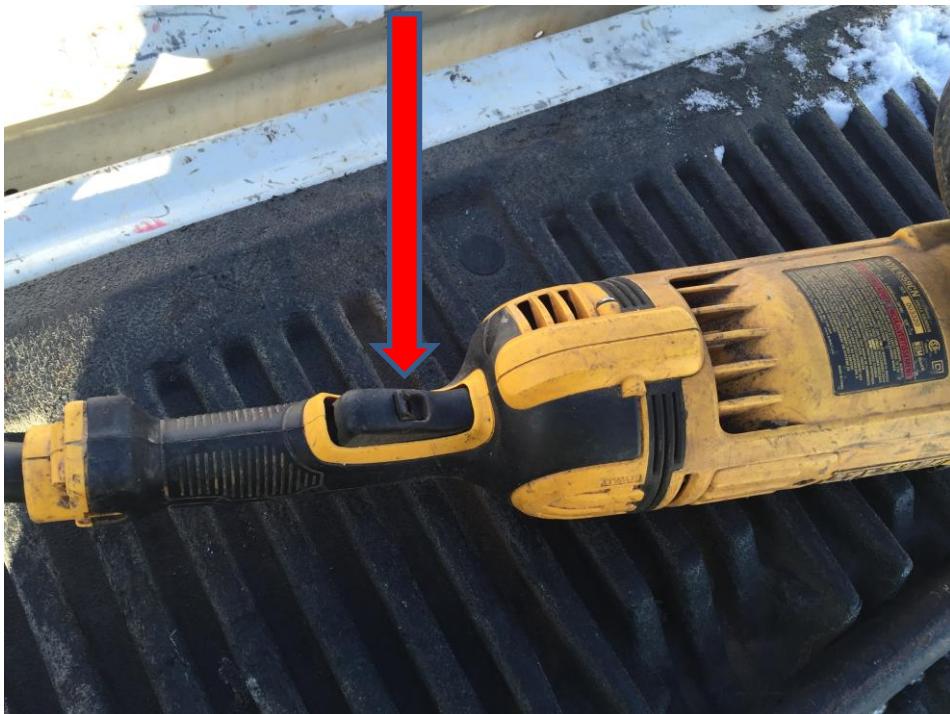
| **Device Trigger** – Arrow shows the safety release in on the trigger of this DeWalt grinder.

1. Whenever any power tools are not in use they **MUST** be unplugged from the energy source; to include when making any adjustments or changes to the power tool. (*We are looking into talking with DeWalt to determine if there can be a double safety switch installed and a different style handle that will be more conducive for performing this type of work*).
2. Inspect and utilize only grinders that have separate safety switches on the grinder; do not use grinders that have safety switches on the trigger.
3. All helpers will be required to utilize the higher cuff welding glove that is currently in use by all welders.
4. A safety stand down with crew to discuss complacency, habits, unsafe decisions, and a refocus of identifying potential hazards associated with each and every task you perform was given the afternoon of the incident.

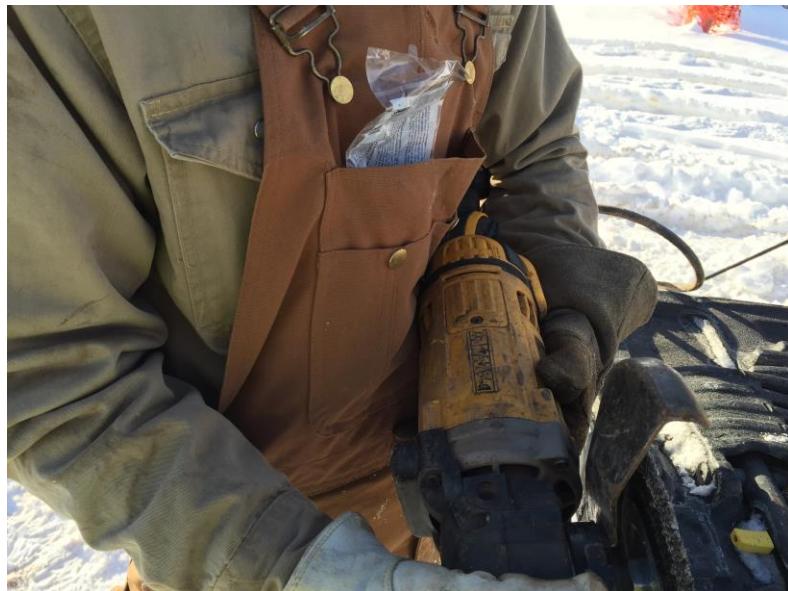
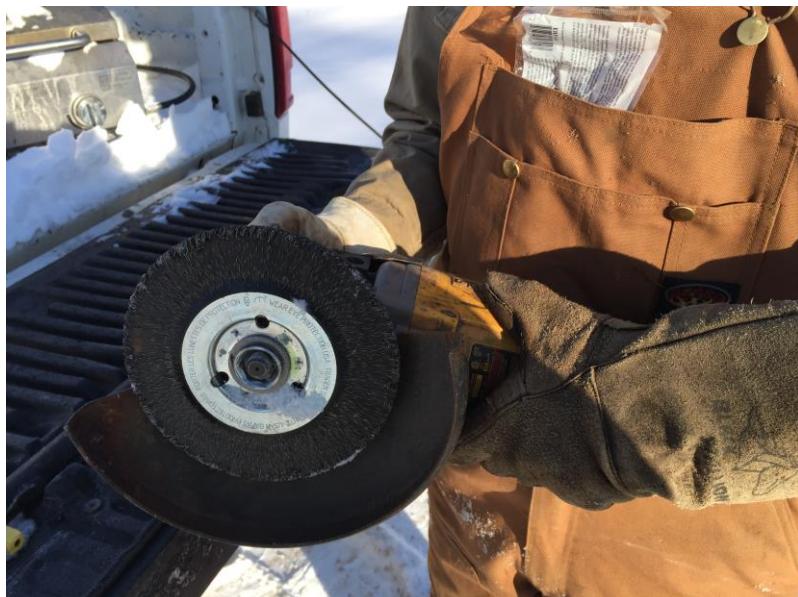
Position of grinder – Here is the position the helper had the grinder in preparing to get in position to buff a weld. The bulky clothes he had on deactivated the safety switch located on the trigger of this grinder.

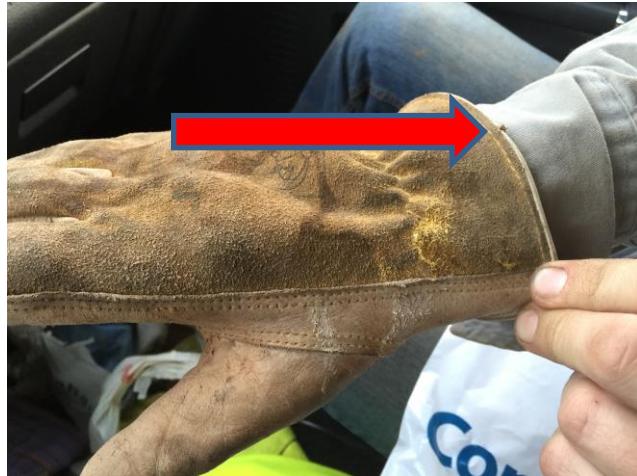
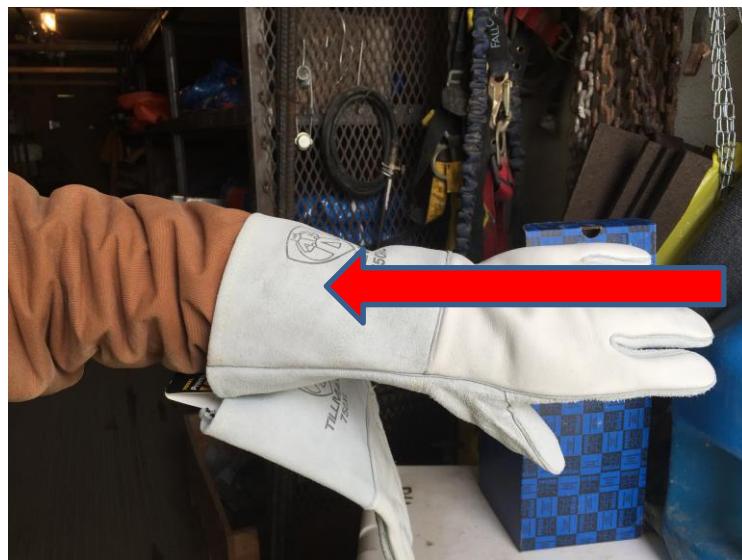
Picture of gloved hand – Prior to the trigger engaging, the helpers hand was covered by this style of leather glove in picture 1 that has a shorter cuff. It is recommended that all helpers utilize the higher cuff welding glove that is shown in picture 2.

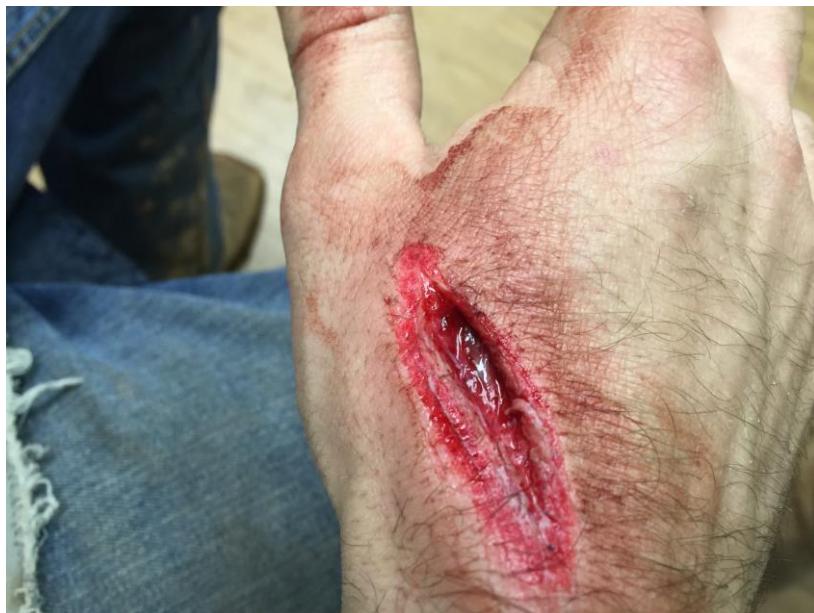
Result of incident – Here is a picture of the end result of the wire brush contacting the helper's hand after being energized and rolling up the shorter glove.
