Learning From Incidents

Pipe Layer Rolls Off Trailer

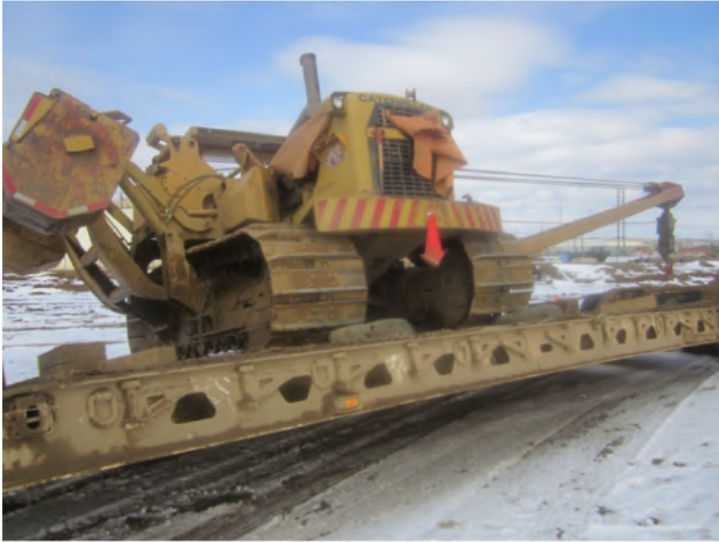
- A pipe layer was loaded and chained down onto a trailer for transport. As the truck and trailer travelled over uneven ground, the pipe layer shifted breaking one of the securement chains. This resulting in the pipe layer rolling off the trailer.

- **Failure to secure** – The employee did not apply adequate load securement
- **Defective tools, equipment or material** – The chain that failed showed indications of corrosion inside the link

- **Inadequate training** – The employees were not trained in proper load securement
- **Improper loading or rate of use** – The capacity of the chains used for load securement were under rated for the weight of the load

1. **Equipment weights must be known in order to select proper load securement devices.**
2. **All levels of leadership must recognize that load securement is a high potential exposure activity in our industry. As such it is critical that a robust verification cycle of training, competency verification and compliance monitoring be in place.**
