HES ALERT

Title :	Incident Report	Incident Date:	27 October 2016, 15:30
Alert Category :	First Aid	Reporting Date:	27 October
Protect Name :	450MW CAPP TR- North, Ashugonj	Client :	Tecnicas Reunidas (TR)

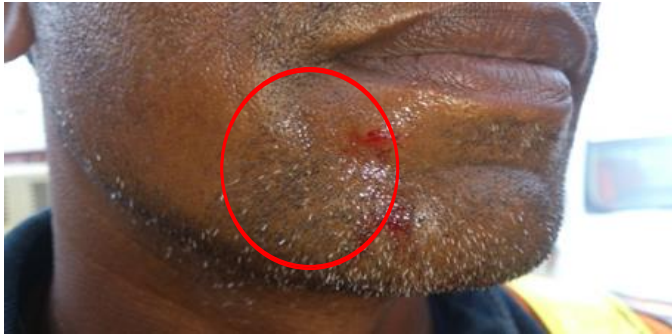
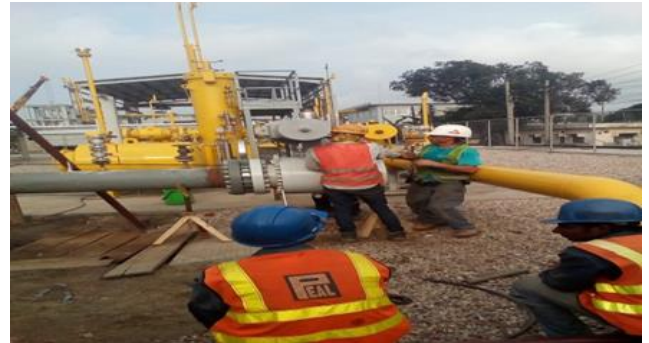
There were some reinstatement work performed with the Maintenance Team. When one (Helper) person was hammering on a valve opposite to another Grinder was standing on line of fire. Suddenly one seam plate got out from valve and hit the lip. Immediately they stopped the work and take out injured person from work location and provide First Aid Treatment.

- Ignoring the safe work procedure during this work time.
- Less of supervision by supervisor.
- Risk assessment was not conducted properly.
- Face shield was not being used during work time who were standing line of fire.

- All work should be followed safe work procedure.
- Pre job safety meeting should be conducted properly
- Ensure risk assessment are completed by supervisor before starting the work.
- Ensure the proper Personal Protective Equipment (PPE).

- Immediately stopped the job and taken the injured persons to site medical.
- Conducted the safety stand down meeting for sharing incident.
- Reviewed risk assessment for hammering job.
- Provided training for specific Job Safety Analysis.
- Provided training to all supervisor to improve more supervision workers.
- Discussed in toolbox meeting for all the construction site.
