Overhead services Near Misses

NM DESCRIPTION

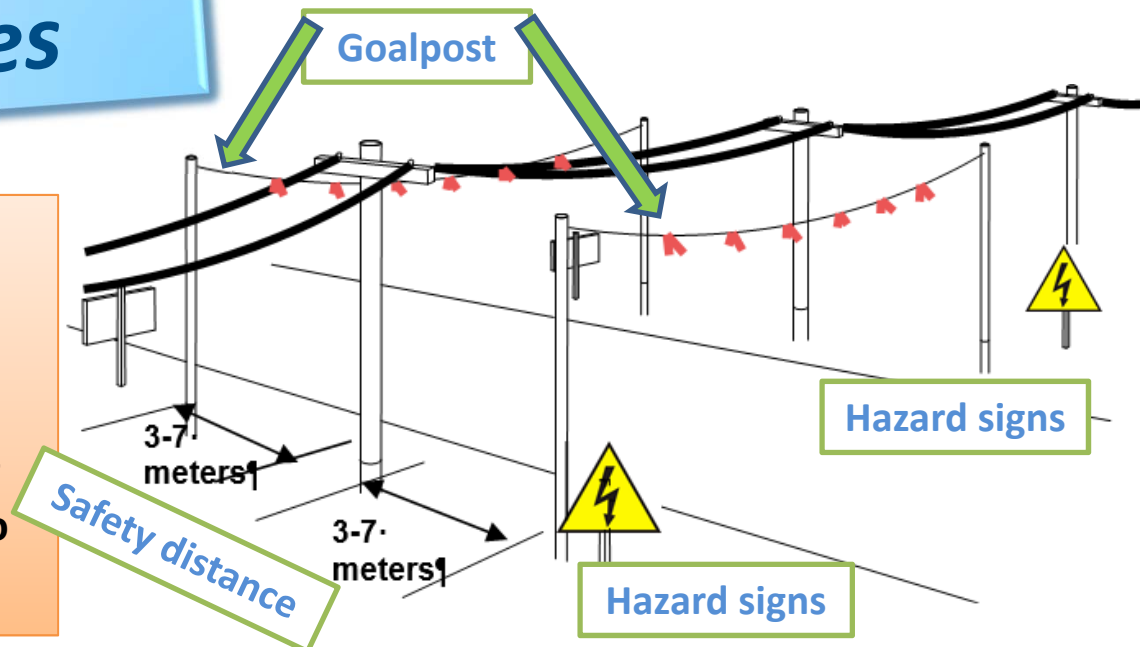
During the crossing the habitat of a Paywelder was kept frontward and completely lifted in order to allow visibility. The boom of the Paywelder touched a 380V cable and struck it to ground for a length of 3 poles.

- ❖ Safe working area was **not marked** and **Overhead service company was not contacted** prior to starting activities as outlined by procedure.
- ❖ **No “goal post” protection.**
- ❖ **Wrong position of the habitat** during the maneuver.
- ❖ **No electric hazard signs** in all the site.

- ❖ All electric lines shall be properly **protected-deactivated** or protected with a non-conducting protection sleeve.
- ❖ Installation of typical set-up for a live electric line “**goal post**” as shown in picture.
- ❖ **Supervisors and operators shall be trained into electric lines risks** and awareness increased in reporting unprotected electric lines - damaged or missing portals.
