HSE Safety Alert

U.S. Pipeline, Inc.

Date: August 25, 2015

Situation: Unsecured auger on float trailer (Subcontractor)

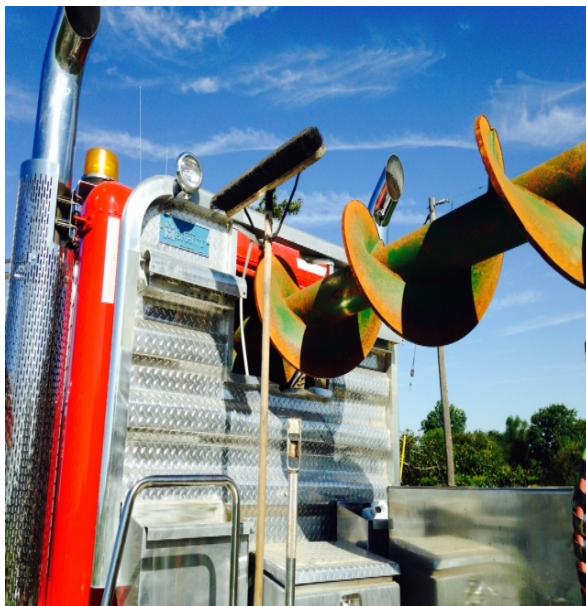
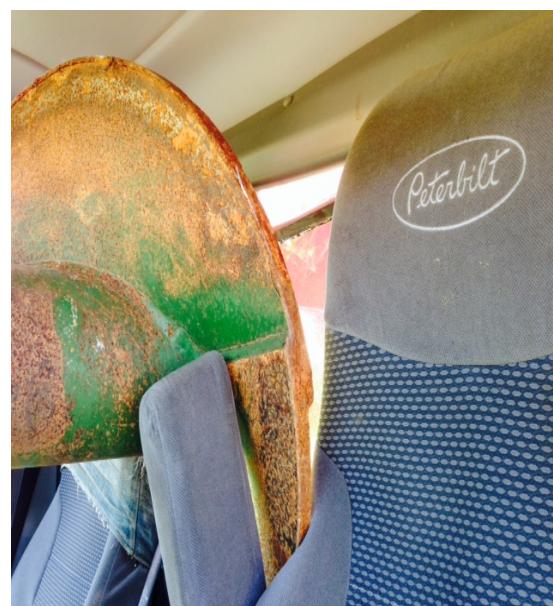
On Monday, August 25th at approximately 0820 am, a subcontractor employee was in the process of transporting bore pipe to the right of way (ROW) utilizing a semi-truck and flatbed trailer. The two seat, single cab truck was equipped with a standard “headache rack” which contained a manufacturer designed opening approximately twenty-four (24) inches by twenty-four (24) inches in order to aid in trailer securement. The opening was located between the driver and passenger seats and centered to provide adequate impact resistance for driver and passenger. The trailer contained three (3) joints of twenty-four (24) inch bore pipe secured in a pyramid configuration. A twenty-four (24) inch auger was placed within each piece of bore pipe prior to loading and transportation as is common industry practice. The driver was travelling to the ROW on highway 10 and attempted to rapidly slow the truck and trailer in an attempt to maneuver onto the ROW. During this process, the auger within the top piece of bore pipe, which was centered on the headache rack opening, ultimately proceeded through the opening and into the cab of the truck. The auger came to rest approximately two (2) feet within the cab between the driver and passenger seating as designed. As a result of the incident, the employee received a minor abrasion to his right shoulder and minor laceration to his right forearm in which first aid measures were applied and the employee was released for full unrestricted duty.

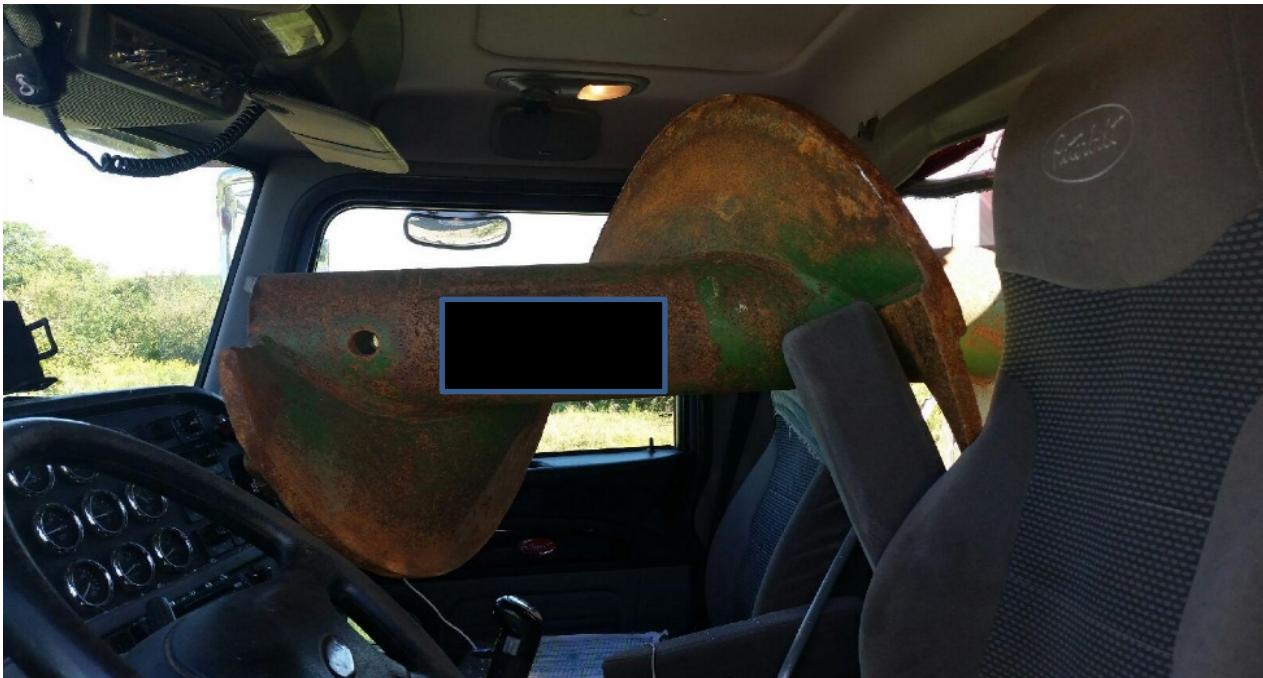
1. Driver had driven route to ROW prior, so there was a broken safeguard that had been put in place earlier on the project (all drivers must pre-drive routes to the ROW access points so they are familiar with the safest routes and eliminating left turns to the ROW).
2. The auger inside the bore pipe was not secured in any manner, either by chain and binder or by welding the auger to the pipe with a tack weld to eliminate movement.

1. Stand Down held at 1PM on 8/25/2015 with the subcontractor employees.
2. A stand down for all Teamsters was held 8/25/2015 at 7AM to address load securement.
3. Teamster was terminated for being in violation of DOT regulations and the subcontractor policy regarding load securement.
4. The subcontractor amended their vehicle securement policies to add specific language for:
 - a. Dummy pipe,
 - b. Dummy pipe loaded with auger,

- c. Large equipment and
 - d. Multiple piece
5. The subcontractor instituted a Load Securement Verification form that requires the signature of the driver and another competent subcontractor employee (Directly addresses the Root Cause).

US Pipeline's procedure has included either welding the auger to the bore pipe or sliding the auger forward outside the bore pipe and using chain and binders to eliminate the movement of auger in the event of an unplanned severe slow down or stop by the hauling vehicle.
