May 2017

OBJECT: CRANE FALLING FROM TRAILER DURING UNLOADING OPERATION

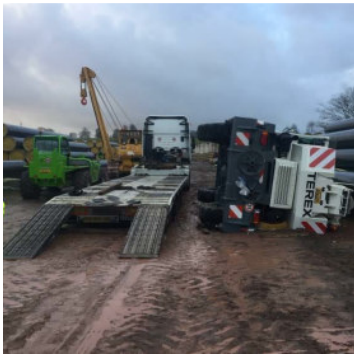
View from the rear of the trailer

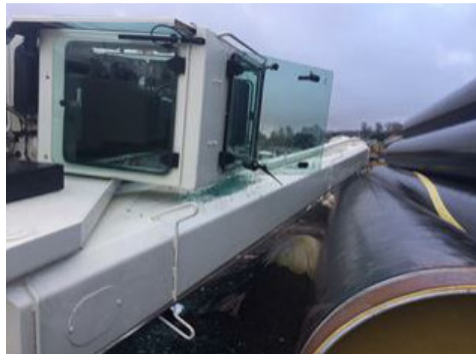
Final position of the crane with the boom on the pipe

- ✓ Worker sustained cut to left eyebrow and some bumps on his leg and hip;
- ✓ Crane damages to right hand side and counterweight area and broken cabin glass;
- ✓ Incident reported to the statutory body;
- ✓ Damage to one pipe.

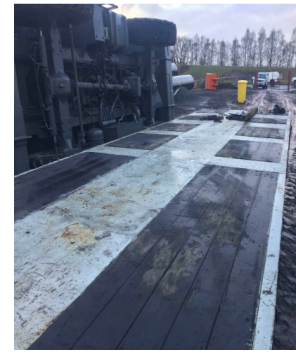
View from the front of the trailer
