June 2017

OBJECT: FACE CUT CAUSED BY USING A GRINDER

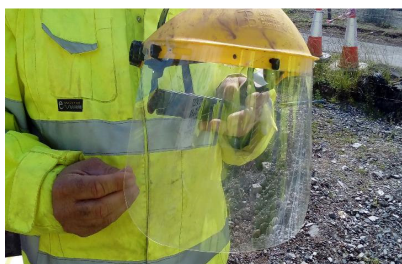
Incident Location

During manual welding, a welder was cleaning a pipe end using a grinder with brush attachment when the grinder kicked back and struck the operator on the right side of his chin. Initial first aid was provided on site and then the operator was brought to hospital. Based on IP & witnesses statements, the accident happened while the IP was grinding in the three o'clock pipe position. The operator sustained a linear wound below lower lip extending to right lower chin. The wound was closed with stitches at the hospital.

- ✓ ERP immediately activated;
- ✓ Laceration of the right side of the chin. Full thickness laceration to chin. Externally 16 sutures, internally 5. No nerve damage.
- ✓ Welding and grinding activity has been temporarily suspended until the conclusion of the incident initial investigation.

- ✓ Inadequate technical skill;
- ✓ Using tools / equipment or materials improperly;
- ✓ Improper position for task: in the opinion of an independent expert, the operator may have assumed an incorrect stance for the three o'clock pipe position;
- ✓ Inadequate or missing PPE: according to statements provided, the operator was wearing correct PPE. The face shield was examined approx. one hour after the incident and was found to be fully intact and without any damage.
- ✓ Inadequate risk perception / risk underestimated;
- ✓ Lack of supervision: supervisor was not present at the moment of the accident.

- ✓ Safety Alert to be spread to SICIM Worldwide operations;
- ✓ Re-Train all welders & grinders on the use of Abrasive Wheel and the required PPE & use Safety Alert in TBT;
- ✓ Enforce PPE compliance with a thorough disciplinary action approach;
- ✓ Safety Meeting with Construction Supervisors regarding the incident and its corrective actions, the minimum PPE requirements for each task;
- ✓ Check adequacy of grinder disks and grinders;
- ✓ All grinders to have dead hand system in place and no rotation hold button;
- ✓ Replace Face Shield, with a complete round face coverage and with more impact resistance, depending of the speed of the disk used on site;
- ✓ Grinders to use Safety Glasses AND Face Shields during grinding operations;
- ✓ Risk Assessment to provide clear / detailed description of PPE to be used by grinders and grinding welders;
