SAFETY ALERT

BROKEN BOOM BLOCK PIN DISCOVERED ON 583 PIPE LAYER
CATEGORY: OTHER (ONSHORE)
CONTACT LEDCOR HSE FOR MORE DETAILS

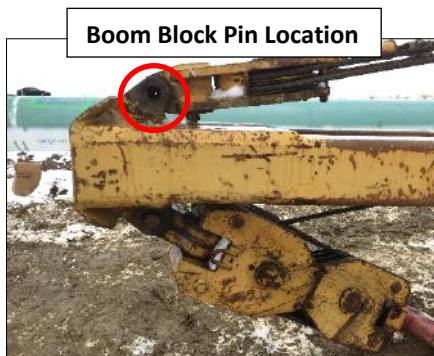
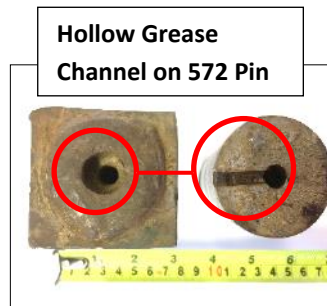
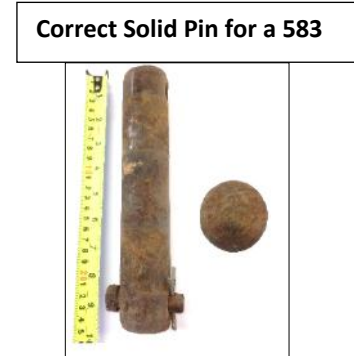
A labourer discovered half of a broken pipe layer pin on the ground in their work area. The labourer had all operator's double check their machines, while they updated the Foreman. The other half of the boom block pin was still in place; the area was cleared, the stick of the pipe layer was lowered, blocked up and locked out. During the investigation, it was discovered that a pin from a 572-pipe layer had been used in place of the 583 pin.

Both 572 and 583 pipe layers use the same diameter pin, however the pin for 572 pipe layers includes a hollow grease channel through the pin, and the pin for 583 is solid throughout.

- The boom block pin was substituted with another pin with a lower capacity at an undetermined time.
- Although key people were aware the pins on a 583 are to be solid, the information is not common place and operators were not inspecting their equipment for such issues.

- Email alert was communicated to all Foremen on the project to suspend all activity with 583 pipe layers until pins were confirmed to be correct.
- All Foremen were followed up with via phone to ensure action had been taken.
- Equipment Managers were contacted to share the details of the issue found.
