LOCATION : Greece
Construction Site

INCIDENT TYPE:RESTRICTED DUTY

DATE: 21/06/2017

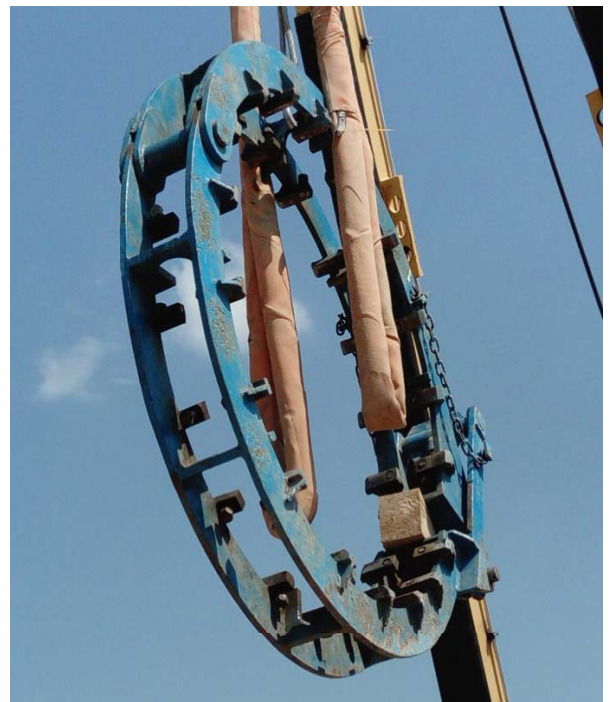
External clamp

During the removal of an external line up clamp on a 48 inches pipeline, the front-end pipe crew – 4 workers - rotated manually the clamp in order to remove it and to place it in another position. Before the clamp was completely removed from the pipe, the finger of one of the worker was trapped among the pipe and the clamp. The worker suffered an injury of the right index finger. The worker was using gloves.

- The pipe crew operating the clamp from both sides of the pipe did not have a direct visual contact between themselves.
- The work was performed inside the canopy, causing restriction in the movements of the workers.
- Poor communication between the team members operating the clamp, unsynchronized actions, without direct visual contact.
- The external clamp weight does not allow effortless handling to the workers.

- The task planning and the level of supervision are critical to raise the awareness of workers involved in such operations.
- The collection of improvement suggestions from workers, tied in with the incentive scheme and with a reward for the best suggestion should be encouraged.
- Classroom and on site hand safety training sessions for all personnel specifically involved in tie-ins and in general in the use of clamps, including foremen must be planned.
- Possible alternative methods for the use of the clamp during alignment and line up of the pipes should be verified.
- Impact gloves for aligning and coupling activities may provide additional protection for similar activities.
- Colour coding of the zones on the clamp where is safe to put hands is also recommended
