Safety Alert

Alert No.: SB001

Posting Date: 3/30/17

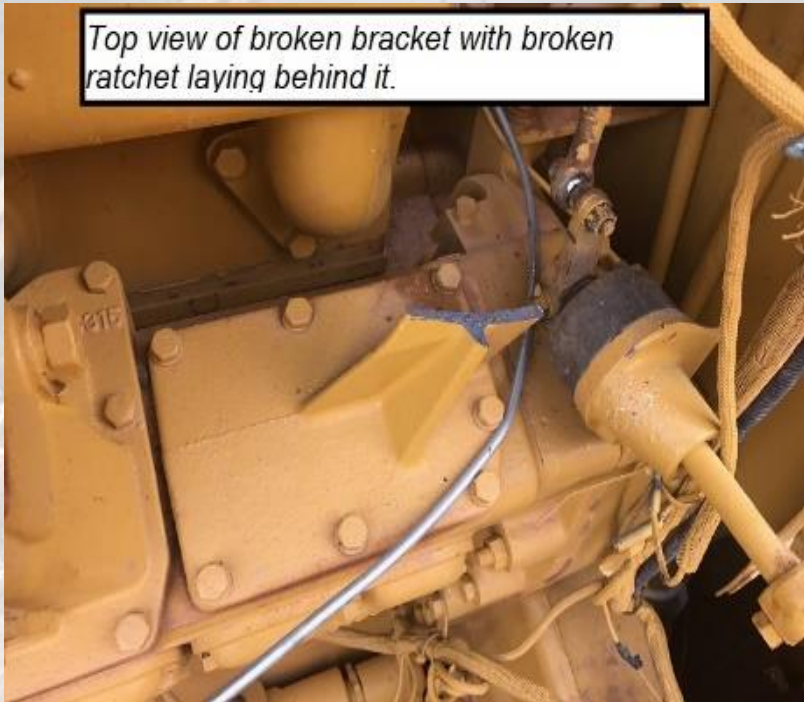
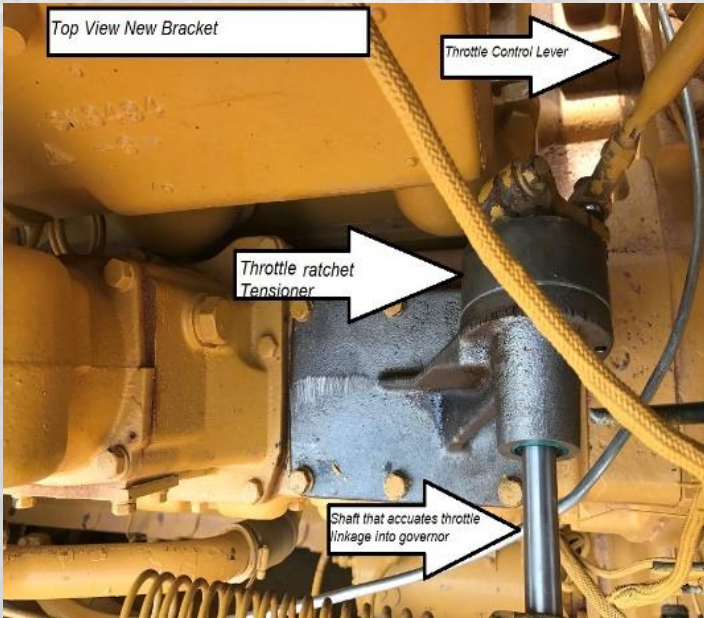
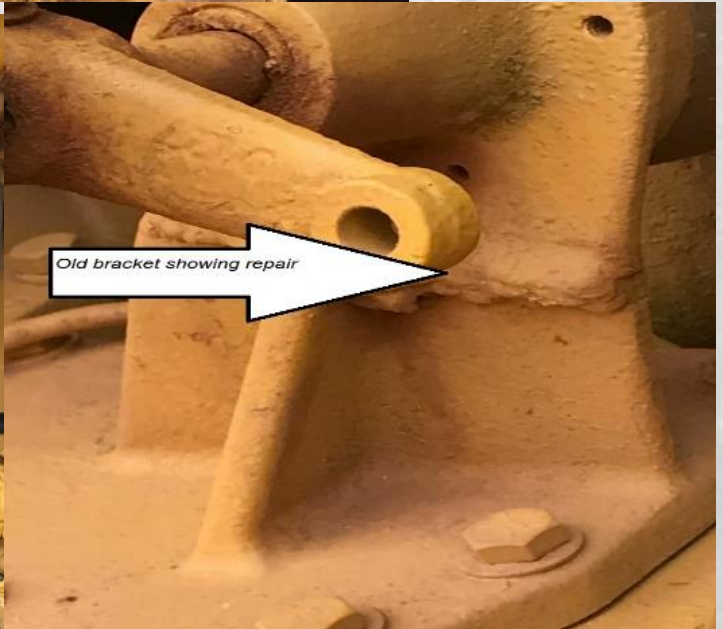
A 594 Side-boom, that was part of a rental fleet, experienced a mechanical failure on a recent project that resulted in loss of throttle control. This was caused by the breaking of the throttle ratchet mounting bracket that mounts just behind the governor onto the fuel pump of the machine. This bracket is located on the operators left, toward the rear of the motor. It can be located by moving the hand throttle back and forth and noticing where the linkage connects to a small shaft in the bracket. When this bracket breaks, the hand throttle is essentially useless and the throttle is at the open position. In the event of this bracket malfunctioning, the awareness to the lack of functionality of the throttle by the operator is key. This is especially true due to the varying degrees of operator experience and familiarity with this machine.

- Communication to side boom operators in weekly safety meetings to the potential of this malfunction and evasive action of disengaging transmission by selecting neutral and engaging brake.
- Evaluation of proper throttle function by the mechanic and/or operator to limit the amount of force applied to this bracket, this may require replacement of the throttle ratchet assembly.
- Increased awareness to operators and mechanics during inspections of these machines to pay special attention to this bracket for stress cracks.
- Assessment by responsible personnel onsite of previous bracket repair that may require a new factory bracket installed.
