# Safety Alert

Alert No.: SA002

Posting Date: 2/6/17

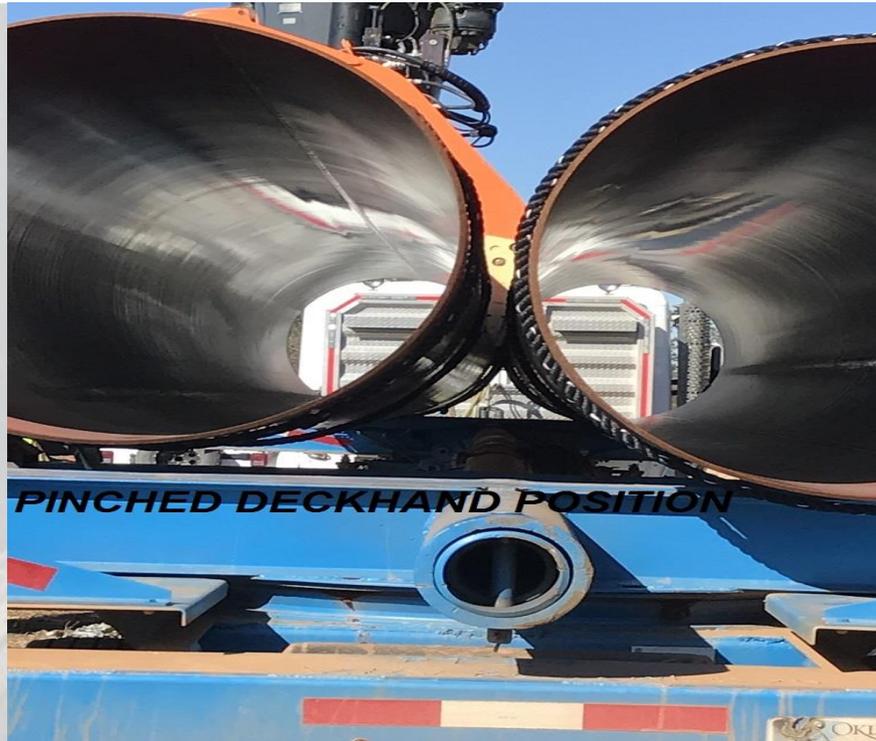
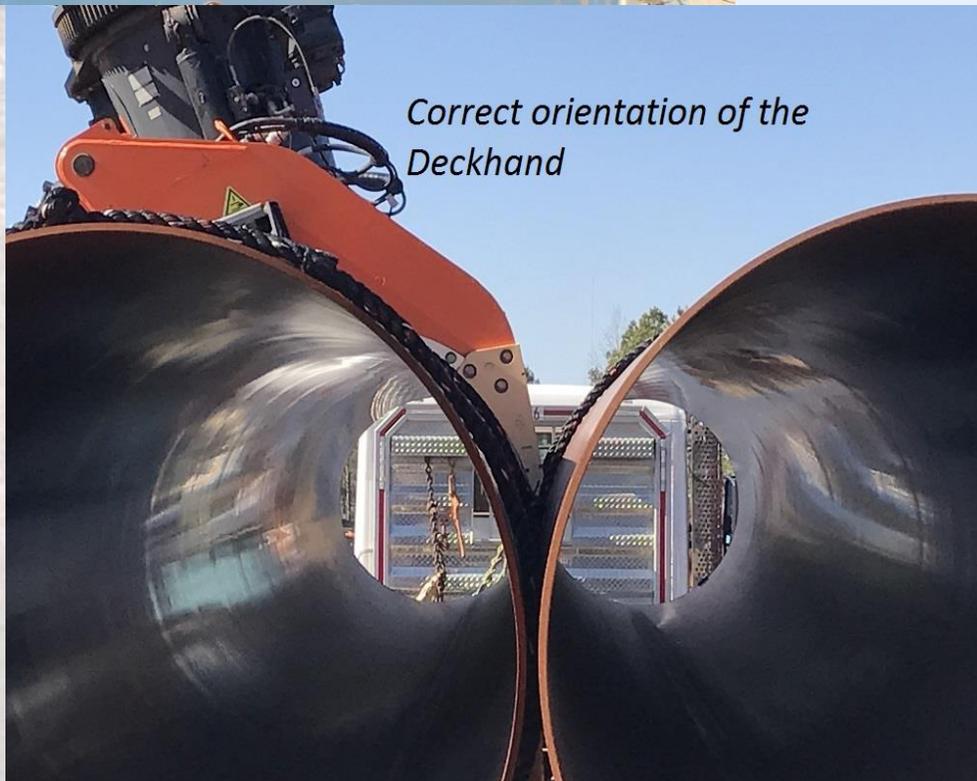
When setting two joints together, such as on a pole trailer, this clamp can become pinched between two joints of pipe. As the clamps on the attachment are released and lifted, the chocks holding the outside of the pipe joints does not allow enough clearance for the clamps to clear. As the attachment is raised without sufficient clearance, it causes a rotation in the pipe, which in turn, allows the pipe to “walk” up and over the chock potentially contacting the ground, equipment, or employees.

The manufacturers manual was acquired and reviewed but did not address this particular situation. The loading process was observed and it was noted that if the chocks were configured in such a way as to allow for proper load securement, while still providing extra clearance for the tapered portion of the clamp. This, coupled with knuckling out of the attachment when placing the joint of pipe next to another joint of pipe positions the clamp in such a way that it does not provide a wedge action between the pipes, which makes clearance between the pipes less critical. This knuckling out of the attachment requires the drivers to position the pole trailer at a distance to allow for the knuckling out.
