# SAFETY ALERT

## PROPERTY DAMAGE – PIPE LAYER CONTINUES TO BOOM IN CATEGORY: OTHER (ONSHORE) CONTACT LEDCOR HSE FOR MORE DETAILS

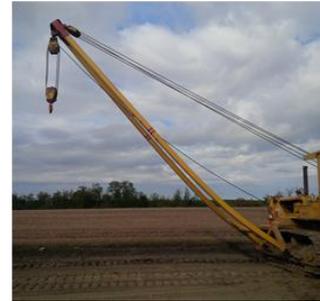
A mechanic had finished installing the boom stick on a Caterpillar 572G pipe layer. While parking the pipe layer, the mechanic noticed that the stick had continued to boom in resulting in the stick bending. The mechanic immediately inspected both winches to see if they were still pulling in but at this point they had stopped. The joystick was also immediately looked at, but it was not engaged at the time. The mechanic then shut off the engine and let out the boom line to relieve tension on the boom stick. The pipe layer was shut down and tagged out for investigation.

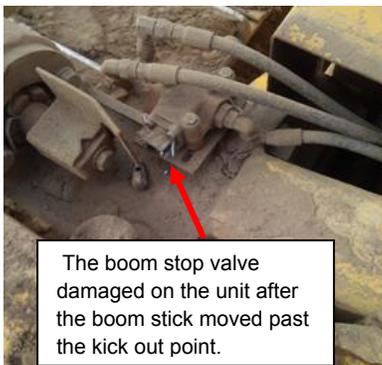
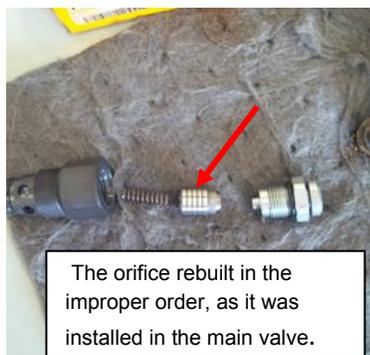
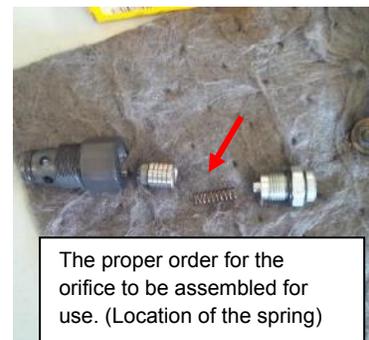
During the investigation, it was found that the kick out pin was only functional at low idle. It would not work at a higher idle. Further investigation showed that the kick out pin was not functioning at higher idle because the orifice on the main valve that regulates the flow of hydraulic fluid to the kick out pin was rebuilt improperly. Further investigation also showed that the boom line control lever would stick in the engaged position due to the bolts on the lever catching on the top metal control panel.

Note: The kick out was tested at low idle prior to parking the Pipe layer and it was found to be functional.

**Using defective equipment:** Previous servicing of the unit left the main valve orifice installed incorrectly, rendering the kick out inoperative with the throttle over idle.

**Failure to check/monitor:** The operator did not ensure that the boom line control lever was in neutral prior to moving.

All Pipe layers in the fleet that had the same hydraulic system were tested for proper kick out response at low and high idle.

The control levers were also tested for the sticking malfunction on all pipe layers.

Additional correctives of investigating a secondary hydraulic or electric bypass system to disabled the boom system will be completed.
