03/2017

**OBJECT: VEHICLE INCIDENT IN THE RoW**

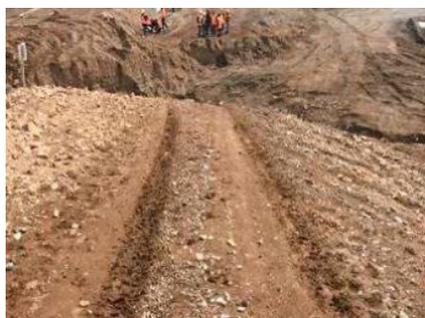
Incident Location: view of the driver

- ✓ Inadequate or missing guards or barriers & warning signs installed in the RoW;
- ✓ Poor judgement of the driver: even though the presence of a warning tape at the top of the slope running across the RoW, the driver did not consider that it may signal a hazard;
- ✓ Conflicting roles and responsibilities & Unclear assignment of responsibility for riprap preparation and for coordination between subcontracted and main activities;
- ✓ Inadequate communication between working groups.

- ✓ Physical earth berms (minimum 1.5m tall), adequate to stop a moving vehicle, to be erected close to the beginning of excavations and to prevent different quote risks in the RoW;
- ✓ Warning signs, barricades, tapes and slope signs to be installed to indicate excavation, slopes and difference in height or in altitude, etc.;
- ✓ All gas cylinder handling and transportation will be done respecting the best practices & the project H&S rules (protective caps, certified metal protection cages, strapping and securing to the vehicle bed).

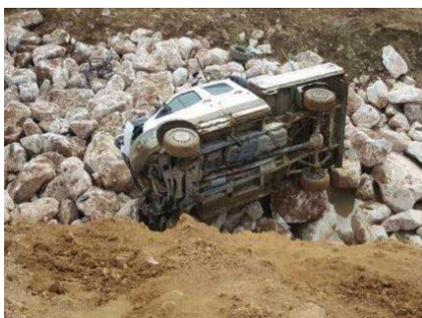
A Welding Foreman was travelling between two different locations on the ROW and was driving a 4x4 Ford Transit utility truck; another worker (grinder) was travelling with him in the front right passenger seat. On the way to the final destination, the vehicle approached a steep slope leading down to a River. Descending the slope, the driver didn't observe on time the RoW sudden stop and following 8-meter drop. When the driver realized the presence of the drop, he hit the brakes, but the vehicle leaped over the cliff and fell onto a pile of rocks used for the execution of riprap (subcon.). The vehicle hit head-on the bottom boulders and ultimately landed on its right side.

Final position of the truck after falling

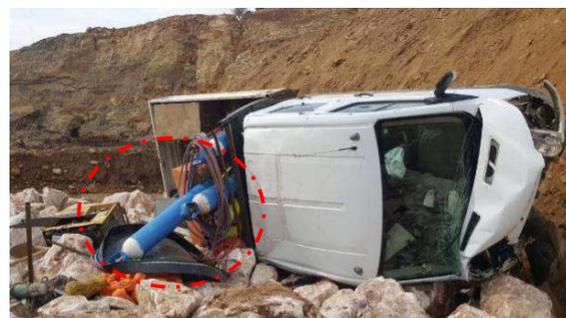
Additional Possible HiPo consequence: multiple gas cylinders (LPG, acetylene, etc.) were carried by the utility truck without protective caps and not properly secured. During the collision, some gas cylinder's valves hit the rocks, but fortunately, none of them suffers any damaged.

Final position of the material that was carried
