Safety Alert

Parking Brake Release

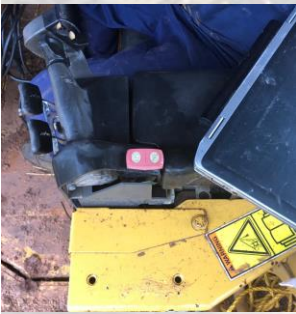
Picture 1

The parking brake system is activated/deactivated via a rocker switch (*Picture 1 & 2*). The rocker switch is protected from inadvertent activation/deactivation by a plastic collar safeguard (*Picture 3 & 4*). In this circumstance, the plastic collar safeguard was not present.

1. Ensure that complete and thorough equipment inspections take place prior to the operation of any equipment.
2. All employees must use Stop Work Authority when deficiencies are discovered.
3. Plastic collar safeguards should be evaluated on all side boom tractors by a competent person.
4. Any safeguards that are defective must cause the equipment to be red tagged until fixed.

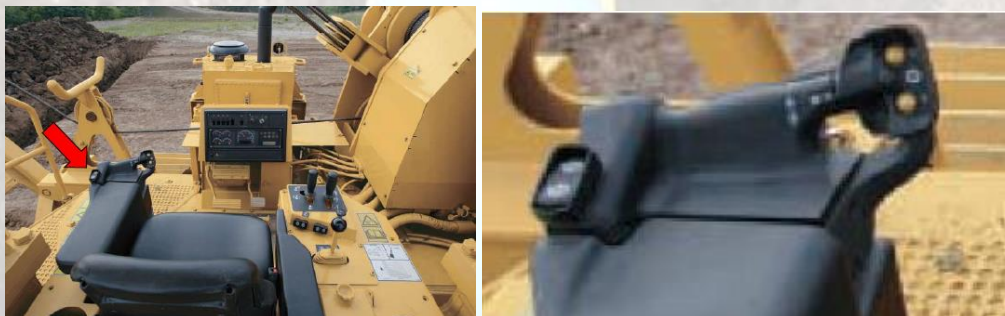
Picture 5: Plastic collar safeguard in place
