Pipe Spool Fell Down And Hit The Person

What Happened?

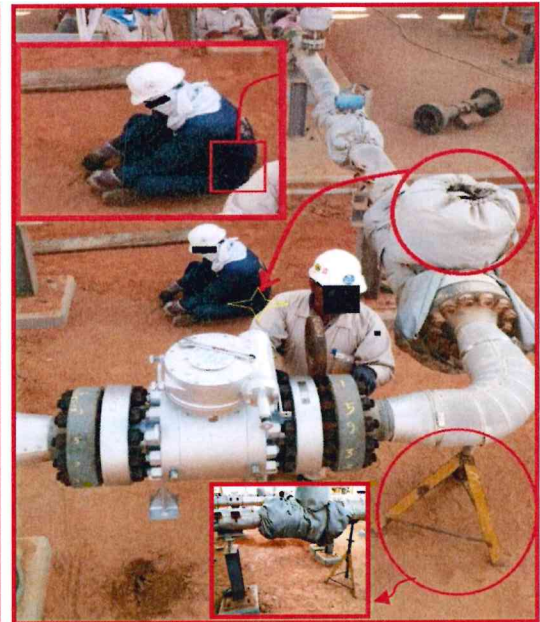
On Thursday 16th of November 2017 at approximately 02.00PM a GPS mechanical crew was performing demolishing of pump 65-P-00027C/E discharge valves to install new 6" valves & MOV at the discharge line. Whilst performing the activity an existing ball valve connected to the pipe was being unbolted to remove it for the installation of new 6" valve. As the last bolt of existing valve was removed the full length pipe got free, rolled from its support and partially fallen down from the end of valve which was unbolted. The butterfly valve which was already installed on the pipe hit the IP left side femur causing multiple fracture on his femur bone who was sitting and cleaning the bolts near to the pipe, placing himself under line of fire. IP was taken to peace land clinic for further investigation. X-ray was taken which revealed multiple fracture of IP's left femur. IP was transferred to Haima hospital for further diagnose and treatment.

- IP was sitting and working in 'Line of Fire'.
- Lack of due care and attention.
- Failed to identify hazards.
- Inadequate Supervision.
- Inadequate temporary pipe support and its placement.
- Guide angle was missing on the permanent pipe support.
- Inadequate work planning.
- Congested work place.
- Noisy Work environment
- Lack of communication
- Failed to exercise Empowerment –SWA
- Many activities performed simultaneously in close vicinity.

- Ensure proper planning of SIMOPs.
- Ensure adequate supervision at all times.
- Use lifting equipment to hold the pipe spool in such type of task.
- Ensure pipe support at right position.
- Readdress Empowerment (SWA) to stop unsafe work.
- Conduct Awareness programme on HIRA, SWA & Hazards awareness.
- Re-design the temporary pipe support.
- Ensure guide angles on permanent pipe support all the time.
