Safety Alert

Winch Cable Damage

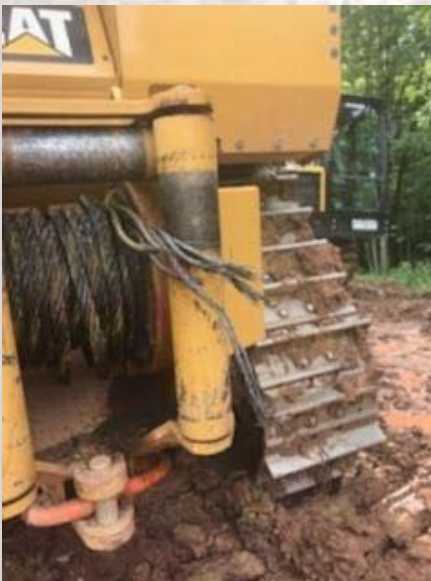
On 7/24/18 at 3:15 PM the Rock Ditch crew experienced a winch cable failure while conducting grading activities with a CAT 336 excavator on Hill 4.

- The slope has a rock ledge that was hammered out the day prior to the incident. The ledge was then covered by dirt to give equipment better traction.
- Approx. 1 hour prior to the incident the slope received a heavy down pour of rain causing muddy conditions.
- D8 #3 was only 20 ft. away from the 336 when the equipment began traversing over the previously covered rock ledge possibly causing both pieces of equipment to lose traction at the same time and shifting all the weight to D8# 2 winch line.

1. Frequent discussion on shockloading and its effect on winch lines.
2. Equipment placement and slope conditions to be reviewed prior to winching operations.

3. Stop the operation if anyone sees slack in the winch lines so winch lines can be slowly tightened to avoid shock load.
4. When additional D8 winch tractors are added in a side by side configuration use additional spotters when views of the winch lines may be obstructed.

5. Communication between operators and the rest of the ground crew to ensure operators can adjust when slack develops.
6. Lines painted on winch line to show stopping point of reel-in function in order to prevent ferrule/ socket damage from reeling them up into the winch.

7. Complete required equipment inspection. Focus on inspection winch line integrity, especially on ferrule/weak points of winch lines.
8. Spotters utilized, when practical, to assist in reel-in process to ensure that reel-in is stopped at appropriate position.

9. Crews to use spotters on the hill to communicate to operators if the winch line drags across the ground or is struck by any falling rocks.
10. Remind crews to never work downslope of any winching operations.

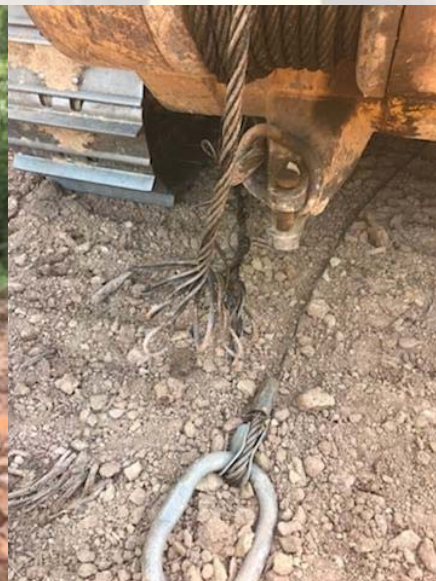
On 7/19/18 at 4:30 PM a Rock Ditch crew was conducting winching operations on Hill #4. The operation included a CAT 336 excavator being supported by 2 CAT D8 dozers while grading the ROW on a 40-degree slope. When the 2 D8s began winching the 336 back to the top the winch cable on one of the support D8s began to fray.

- The uneven terrain made it difficult for the equipment to stay in timing.
- Operators and spotters did not communicate with each other when slack began to develop in the line.
- When slack develops in winch lines the operation should be stopped to correct the issue and avoid shock load to the line.

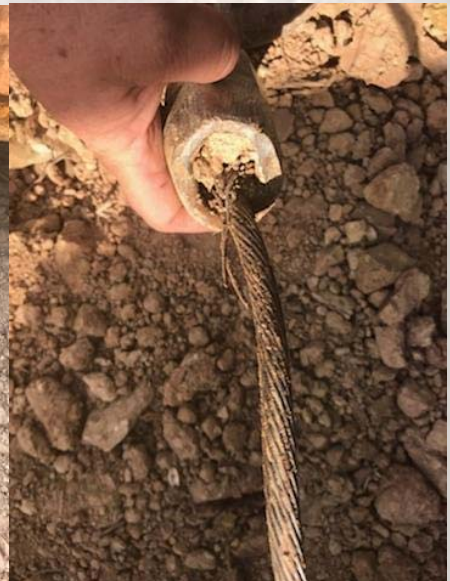
On 7/10/18 at approx. 1:30 PM a hill crew was conducting cleanup operations on hill 7 using 2 CAT D8 dozers connected together by the 1 ¼" winch lines. Sometime during the operation one of the winch lines became damaged by a rock causing one of the strands to be broken and the thimble to be damaged.

- During the process of lowering the bottom D8 the line can develop slack as the blade pushes more dirt causing the D8 to move slower than the top D8 is lowering down.
- When the line develops slack and sags down where it can be dragged across rocks.
