# SAFETY Alert

N° 01/2020 Date: January 2020

**OBJECT: NEAR MISS DURING HOT FORMED BEND ALIGNMENT OPERATION**

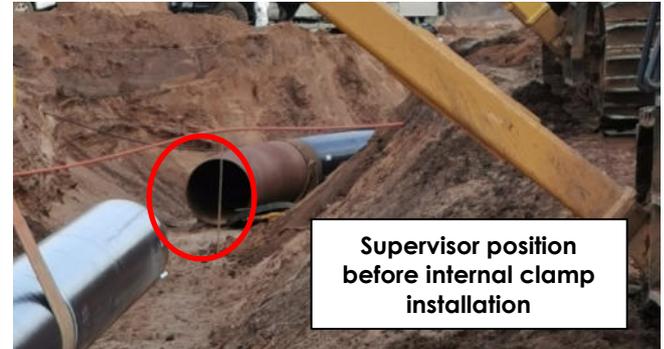
While lowering-in the pipe a banksman was present to give the supervisor's information to the sideboom operator.

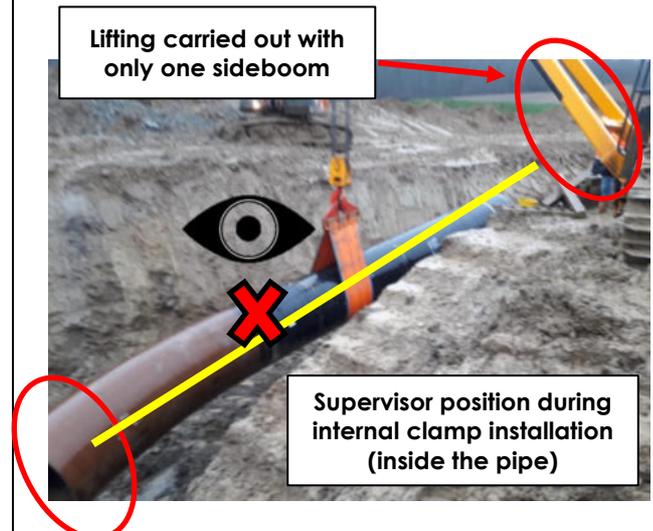
There was no visual contact between the sideboom's operator and the supervisor. All workers were waiting for the installation of the clamp.
