OSHE-ALERT 2021-08

Place: Denmark

Date: 29/09/2021

Falling down of a steel beam.

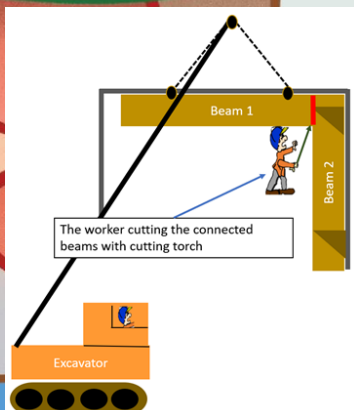
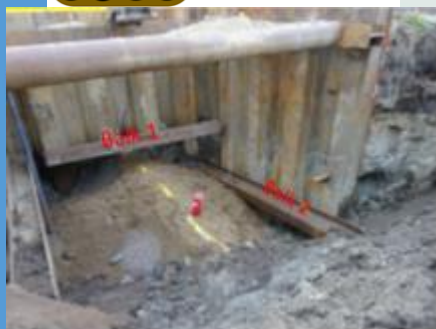
During dismantling the sheet piling pit, two steel beams had to be separated using an acetylene torch.

The two steel beams were lying on top of each other.

Beam 1 lay on beam 2, beam 1 was secured by a hoisting chain attached to a lifting machine for easy removing after burning off beam 2 (which lay on two supports).

A small part still had to be cut. Therefore, the operator of the excavator lifted beam 1 to see if the beams were already loose.

As the beams are not loose yet, the operator put beam 2 back BUT not completely on the support.

Then the last piece is cut, beam 2 is tipping downwards and hits the worker (resulting in scrapes).

- No verification that beam 2 is resting securely on the supports.
- No securing of beam 2 by a lifting machine.
- Not aware that a hanging beam always pulls/moves a little in relation to the fixed construction.

- Never check whether a load (here beam) is loose by hoisting it.
- Drawing up and following a detailed work plan, for the dismantling (incl. associated hoisting plan).
- Securing the load and the construction before starting the work.
- LSR: I never work under a suspended load.
