Hammer Drop Incident

- Incident: Dropped Sledge Hammer
- Date: 10.07.2011
- Actual outcome: Dropped Sledgehammer
- Potential outcome: Severe injury

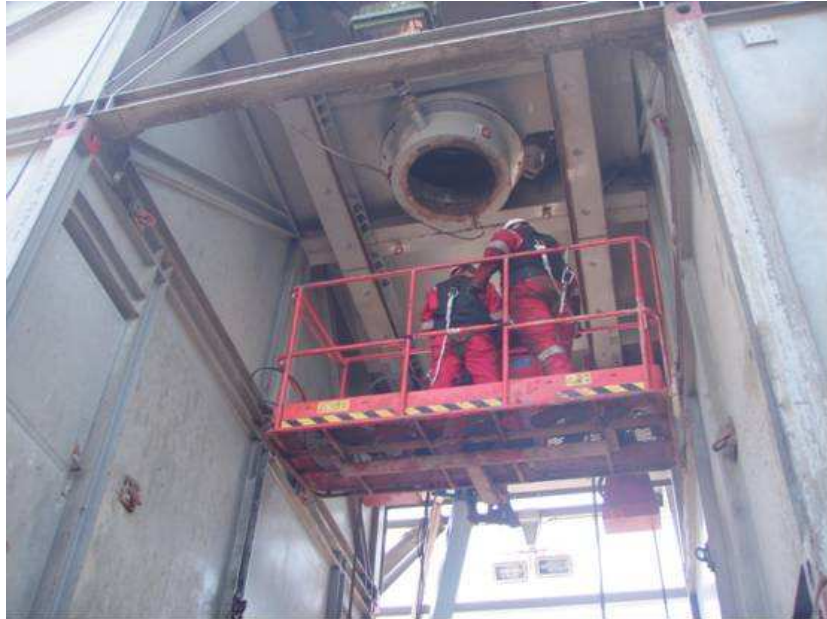
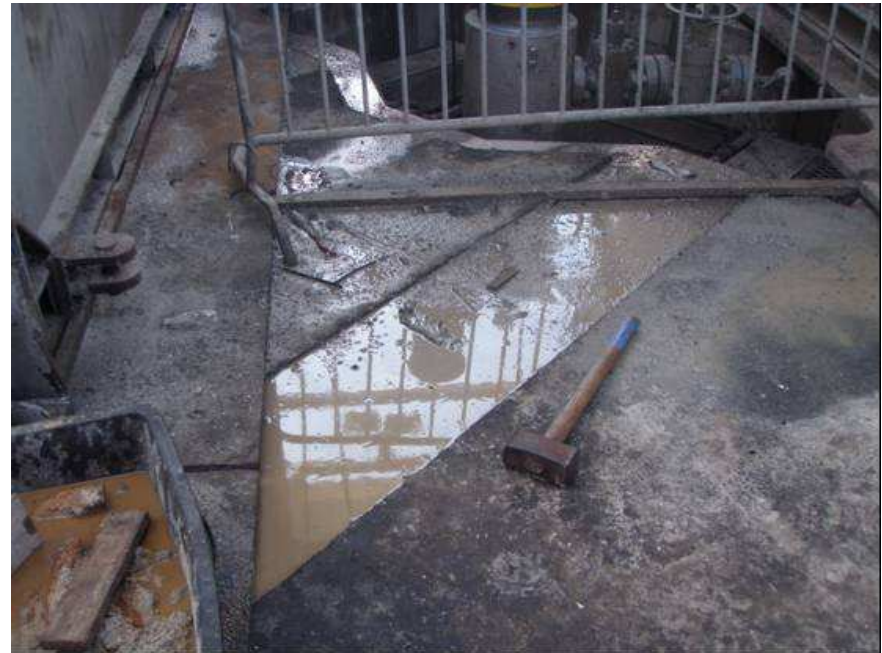
To set an additional hydraulic cylinder, 2 employees used a working platform, in order to reach the workstation in the approximate height of 8 m. (please refer to pictures) When applying the transportable lifting cylinder they noticed, that the lifting height is not adequate. In order to bypass the missing height a 5 kg hammer was used as a base. When the mast bolt detached from the anchorage the hammer fell on the floor (please refer to Picture)

- The transportable hydraulic cylinder was not used according to the rules
- Abutment was not secured according to the rules (5 kg hammer)
- A sledgehammer (5 kg) was used as an abutment
- Hammer falls in blocked area, after bolt loosened itself suddenly out of the anchorage

Action Description		Date
1	Incident passed on to the Design Department. Constructive possibilities were surveyed.		Calender week 32
2	Immediate measures for maintenance have to be implemented (grease of the bolts)		15.07.2011
3	File steps of procedure during Rig Move		Calender week 35-36
3	Verification of existing JRA, if necessary creation of missing JRA		Calender week 36
4	Check level of training of employees and if necessary resolving of training backlog with training measures		Calender week 32
5	Assignment of a Safety engineer from the HSEQ-Management Department in order to supervise the safety at work		Calender week 31
