# Rupture of a buried electrical cable

## NM DESCRIPTION

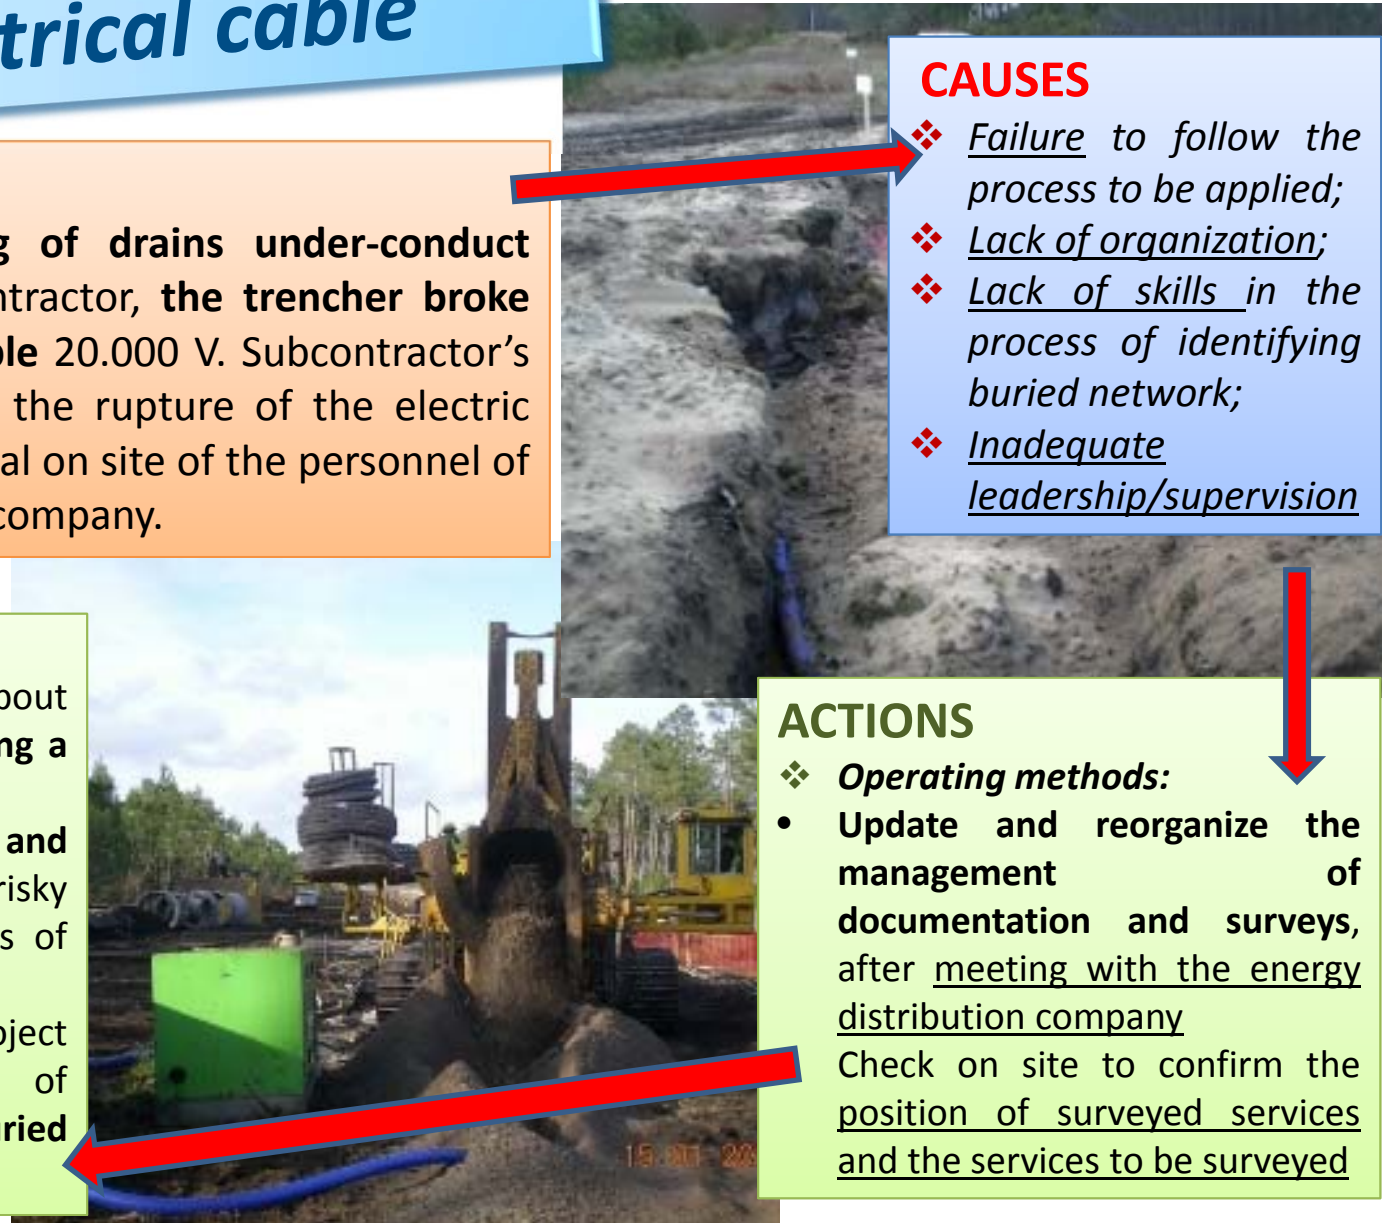
During the **positioning of drains under-conduct** performed by a subcontractor, **the trencher broke an electrical buried cable** 20.000 V. Subcontractor's staff became aware of the rupture of the electric cable following the arrival on site of the personnel of the energy distribution company.

- ❖ Failure to follow the process to be applied;
- ❖ Lack of organization;
- ❖ Lack of skills in the process of identifying buried network;
- ❖ Inadequate leadership/supervision

- Share information about the Near Miss by **issuing a Safety Alert;**
- **Inform companies and employees** about risky situations and all kinds of accidents;
- **Training** regarding project specific process of **identification of buried network.**

- ❖ **Operating methods:**
  - Update and reorganize the management of **documentation and surveys**, after meeting with the energy distribution company
  - Check on site to confirm the position of surveyed services and the services to be surveyed
