Learning Through Experience

Location : ALGERIA

Incident Type : HIGH POTENTIAL

Date: 14/07/2016

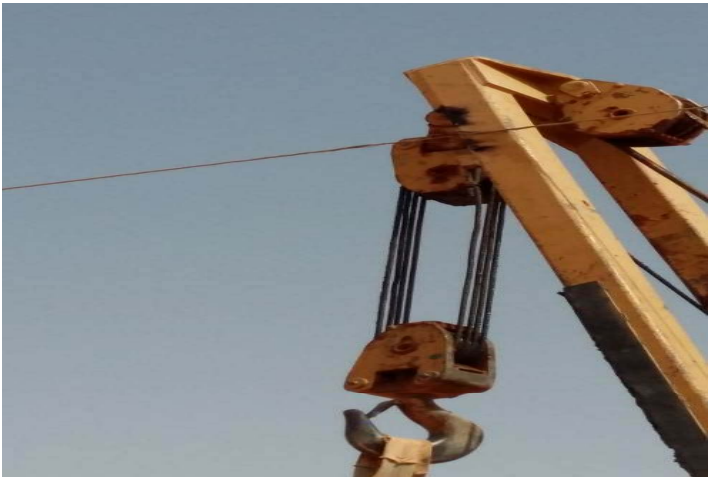
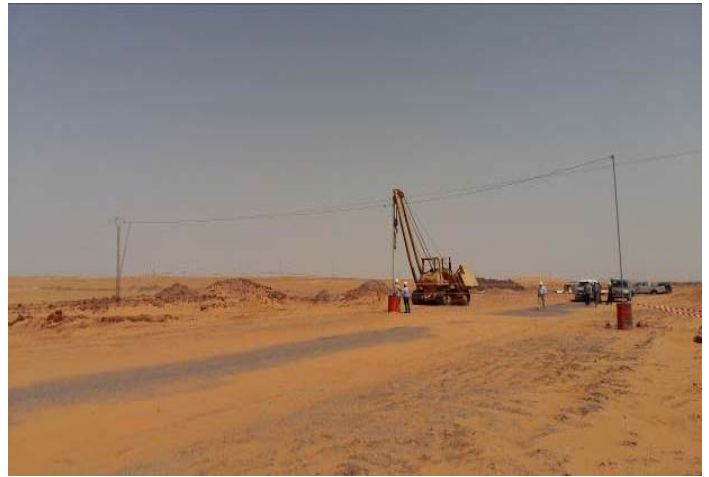
Incident location

On 14 July 2016 at approximately 09:10 AM a side boom was travelling on the Right of Way to assist the tie-in crew. On the way the operator hit a 30 KV (High Voltage) Overhead Power Lines (3 rows of power cables). Two of the three power cables were cut off and the third one was severely damaged but still hanging overhead, resulting in property damage and no personal injury.

- The operator travelled with the side boom in reverse for a long distance with the boom almost vertical position and without flagman or any other type of escort to avoid a possible contact with the side boom to the OHPL.
- One goal post was missing
- Inattention to surroundings, the operators was unable to notice the OHPL
- Unintentional human error
- Complacency

- Ensure the presence of Goal Post near the Overhead Power Line and signs installation of High Voltage Risk.
- Supervisor must ensure that the operator receives the correct information and understands it.
- TBT and RA must be discussed and share with all crew involved for the activity.
- Supervisor/Foreman must ensure the presence of escort and flagman during the transfer of any heavy equipment at work site.
- Supervisor/Foreman before to start any activities must check and verify the presence of any hazard at site.
- Any unsafe condition or anomalies must be communicated to site Supervisor or Management and close it immediately to prevent incident.
