# LESSONS LEARNED

## Compressed Air/Gas Exposure

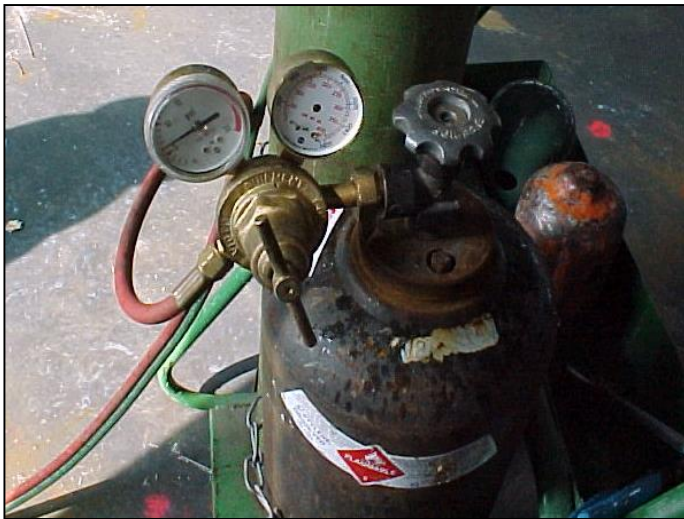
Employees were cleaning an air paint sprayer and had unscrewed the filter canister lid. During re-assembling, the employees mistakenly thought the lid had been screwed back on. When the air pressure was turned back on, an employee stood directly in front of the canister. Without the lid being completely tight, it blew off, splashing paint thinner in his face.

- Inspect equipment and parts during disassembly and reassembly.
- Confirm assembly is complete according to the manufacturer instructions.
- Position yourself in a protected area when pressurizing equipment. Don't stand next to or in front of parts or gauges that could fail - paint sprayers, sandblasting pots, oxygen & acetylene cylinders.

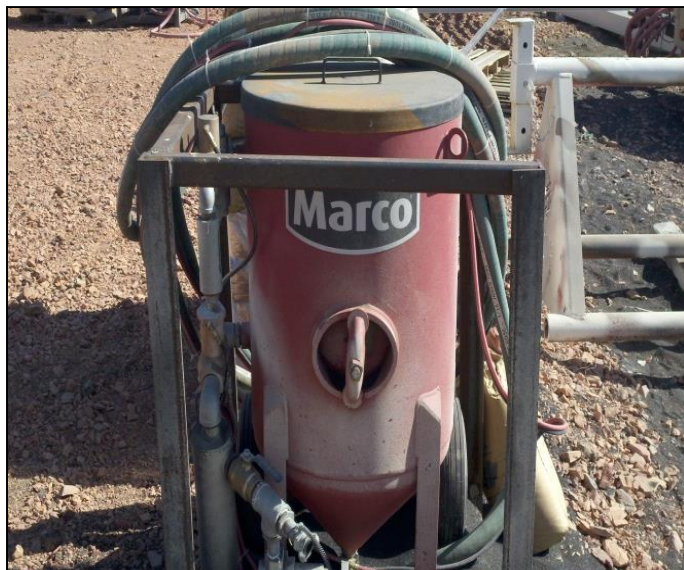
- Threaded lid was not inspected for damage.
- Lid was not confirmed to be secured tight.
- Employee stood next to area where parts under pressure could separate and strike them.
