Learning From Incidents

Dropped Flange Due to Sling Failure

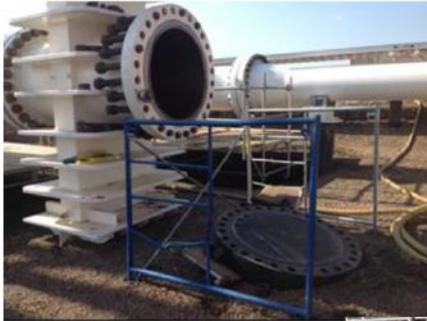
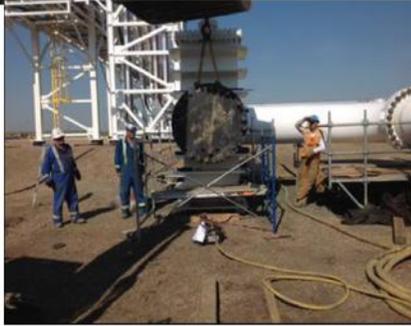
- Using an excavator and two nylon slings the crew started to removed a 1700 kg flange.
- After being pushed through the flange bolt holes to create a basket configuration, the slings became exposed to the unprotected sharp edges of the flange.
- As the load was raised the slings were severed. The flange dropped to ground, damaging the platform planks and a side brace before coming to rest.

- **Improper rigging:** The nylon sling was not protected from the sharp edges on the flange bolt holes.

- **Inadequate initial training:** Crew members did not receive proper rigging instruction.
- **Inadequate assessment of needs and risks:** Crew did not identify and adequately protect against the potential hazards associated with the use of slings directly on sharp edges without softeners.

1. **Provide training on proper rigging and hoisting techniques for those involved lifting operations.**
2. **Use purpose built rigging equipment (ex. flange lifters) when hoisting flanges.**
3. **Where purpose built rigging does not exist, make use of an engineered sling protector where sharp edges exist.**
