LESSONS LEARNED

Excavator Rollover

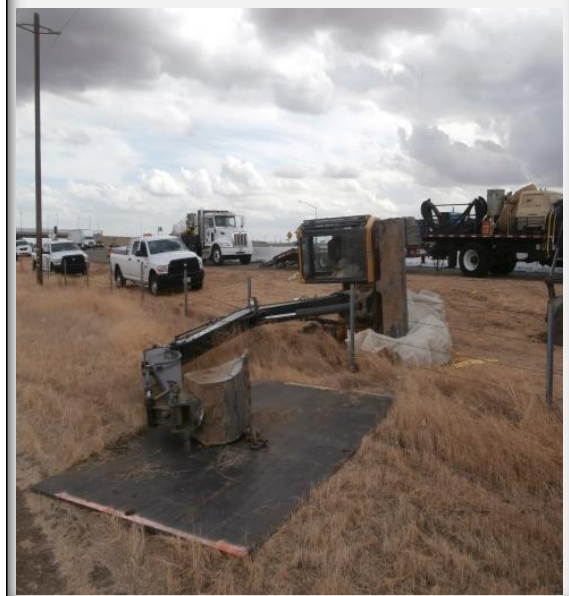
The Operator was tasked to move road plates from the lay-down area to the excavation with a model 85G John Deere Excavator. The excavation was on the other side of a 42" high barbed wire fence. When the operator arrived near the excavation, he sat the plate down, repositioned excavator, and lifted the plate over the fence. Once the plate cleared the fence, the operator boomed out, and started to lower the plate. At this point, the plate's inertia counter balanced the excavator causing it to slowly tip over.

- Operator exceeded the manufacturer's excavator lifting capacity for lift configuration.
- Excavator was not setup on level ground to maximize its capabilities.
- Operator failed to utilize excavator load chart or plan the lift to confirm the lift could safely be accomplished. See photo on right.

- Train operators on reading and understanding load charts, configuring load weight, and knowing equipment lifting capabilities.
- Take the time to plan your lifts with everyone involved in the lift.
- Know the capability limits of the equipment you are operating.
- Ensure tasks and steps are clearly defined with supervisor's participation.
