# Safety Alert

## INCORRECT PRESSURE GAUGE ON HIGH PRESSURE SUPPLY LINE

*safety alert number: 284*

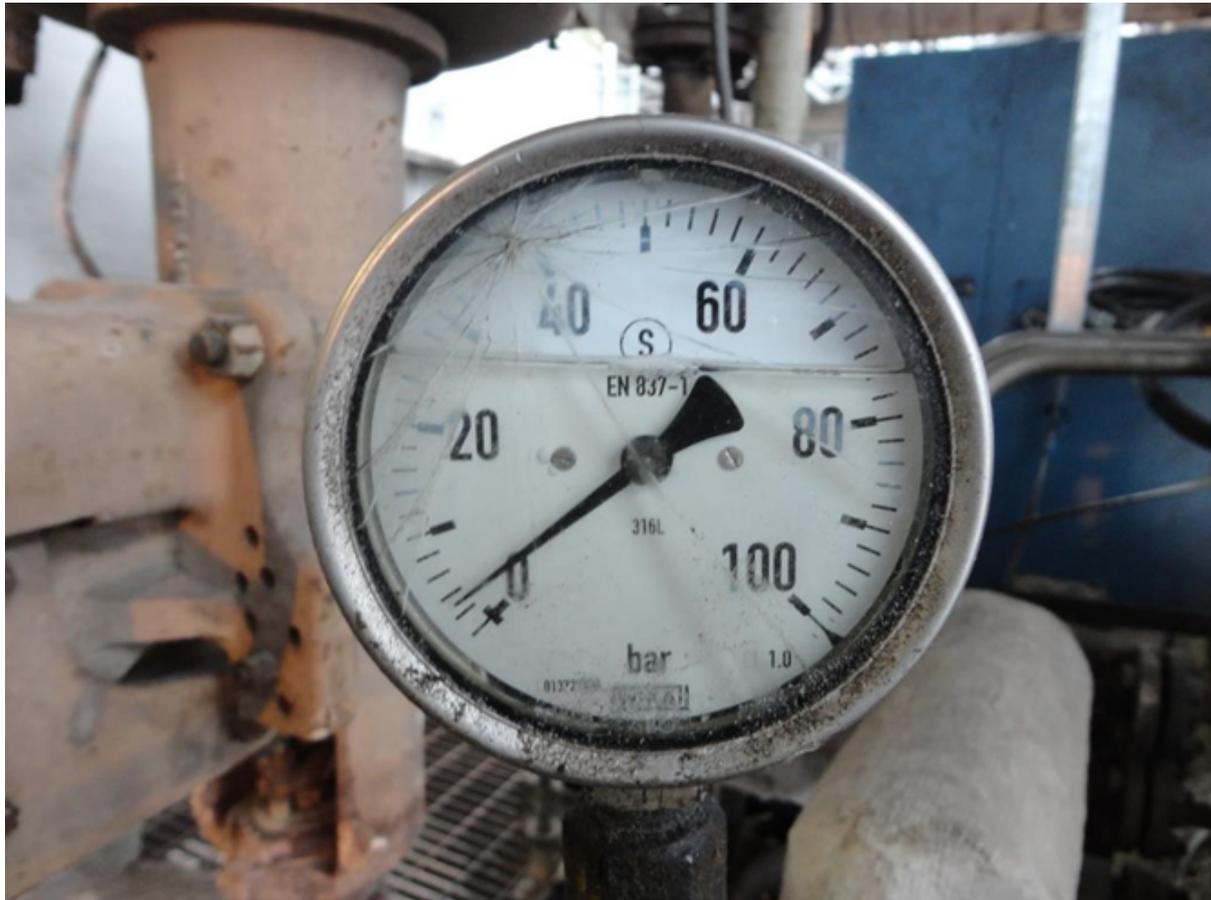
Figure 1 – Correct pressure gauge (Bar)

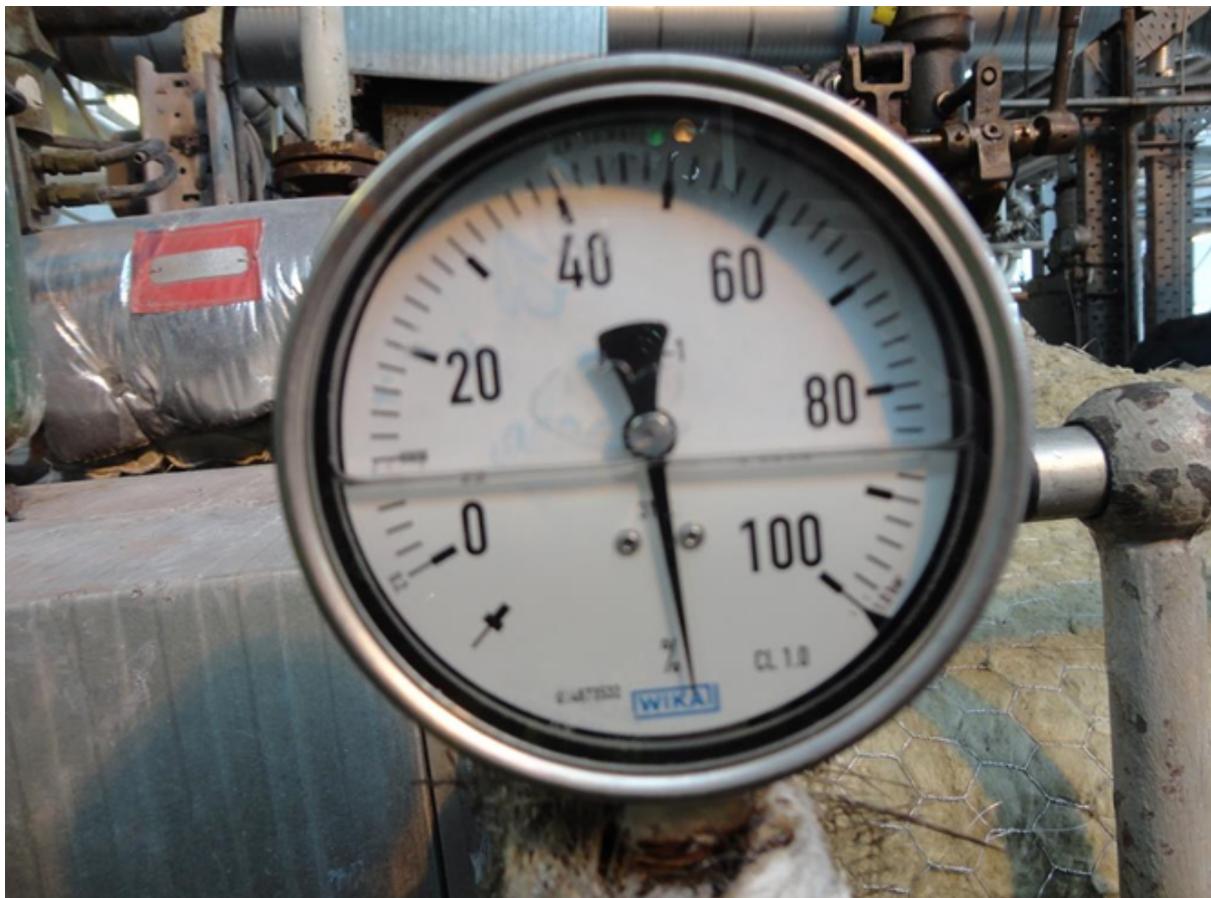
When re-commissioning a Steam Turbine following maintenance, a small steam leak was observed from a pressure gauge located on the high pressure steam supply. The pressure gauge was rated to one Bar(g) and the safety seal failed when it was exposed to 55 Bar(g) steam during re-commissioning. The pressure gauge in question was brand new and had been fitted during the recent maintenance period.

- Operations inspected the pressure gauge and found it to be a 0-100% gauge, where a 0-100 Bar pressure gauge should have been installed.
- The 0-100% gauge had been ordered in error for a prior boiler shutdown and had been subsequently stored in the utilities equipment room, rather than returned to the warehouse for disposal.
- Technicians had established a culture of storing some small items in equipment rooms to allow easy access for small maintenance tasks.
- On the day of installation, the 0-100% gauge was mistaken for a 0-100 Bar pressure gauge (due to the near identical appearance) and was taken from the utilities equipment room and installed on the steam turbine high pressure steam supply line. A human error mode of "miss-perception" was recorded following a Human Factors investigation.

Figure 2 – Incorrect Pressure Gauge (%)

- Check all stores stock to ensure that all pressure gauges are stored in the correct place and in the correct boxes.
  - Ensure that all un-used equipment is returned to the place of issue at the end of each day. This ensures that only the correct equipment for a specific work order can be withdrawn.
  - Ensure that all pressure gauges are function checked and fit for purpose before installation.
  - Review stores stock items and material numbers to establish those that are no longer used or required. Block all numbers that are not required in to prevent re-ordering by accident.
  - For legacy assets, review and rationalize all local pressure gauges across each facility with a view to removing those that are no longer used or required.
-
