# Lesson Learned No-42

## LOWER HOOK BLOCK AND UPPER SHEAVE DROPPED TO GRADE FROM SIDEBOOM

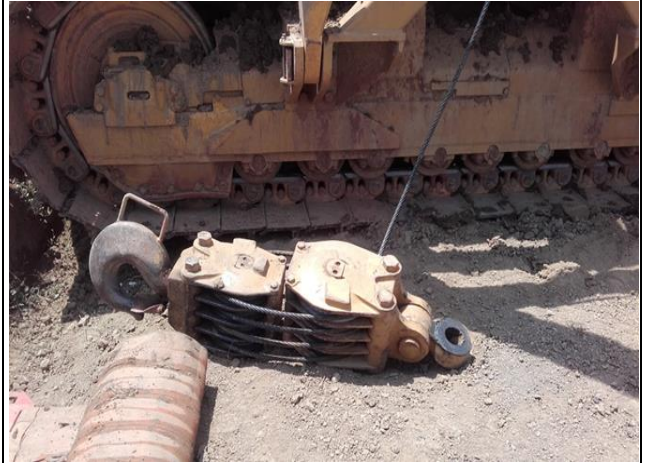
### Photo

During a Tie in activity a lower hook block and upper sheave block (450kg) became disconnected from a raised boom on a Side Boom and fell to the ground during a small manoeuvre. Shortly after, the axial pin also fell to the ground (12kg)

The sideboom had previously been transiting along the ROW to complete multiple activities which contributed to the loss of the securing bolt and washer and subsequently the axial pin due to the prolonged period of vibration and movement.

- Work Stopped
- Investigation team formed
- Fleet wide check of Side booms for similar issues

- Reinforce check by the operator - Mandatory to fulfil checklist prior to start working in the morning and after lunch break. Signature of operator required. 2 boom down inspections daily or in the event where the boom is holding a fixed load immediately before beginning next lift
- Plant departments to re-evaluate the security pin to ensure correct pins being used for the side boom model
- Plant departments to carry out monthly critical point inspections of all sidebooms
- Use of Tags on security pins to be used. Tags enable the checking of placement of pins from a distance.
- Some older sideboom models have original parts that are no longer available and instead substituted fittings are used – The need to check plant inventory that substituted parts are fit for purpose.

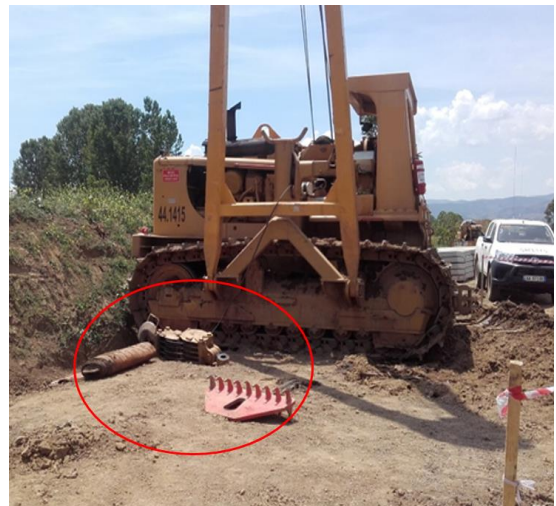
- Inadequate planned preventative maintenance undertaken
- Pre-use inspection checklist not completed
- Sideboom travelled distance along ROW – vibration contribution to pin loosening
