HSE Alert No. 02

PROPERTY DAMAGE - MV Neutral OHL Damage

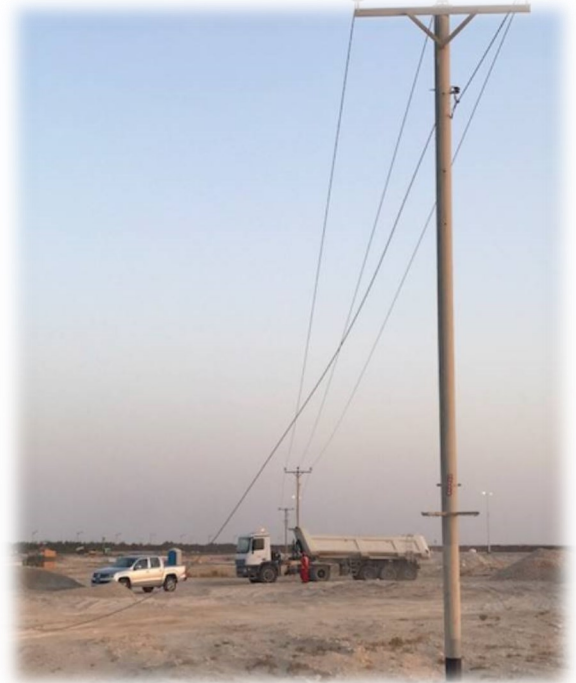
At about 17:00 hrs 2nd of July 2017 at a crossing zone (km 1+150), a significant incident occurred where MV neutral overhead line belongs to local Electricity Authority cut and damaged by the tipper truck with belongs to the subcontractor.

The incident occurred when the truck driver did not lower down his tipper truck dump bed after unloading the sub-base materials to the location, consequently, while crossing under the overhead line, the titled dump bed struck and cut the overhead line.

- Goal post and warning sign was not provided adjacent / under the overhead line.
- Dumping activity and stockpiling area was carried out nearby the overhead line.
- Site road access provided crossing under the overhead line.
- No available flagman during dumping activity.

- All access near and crossing OHL closed with solid barriers made across and under the OHL as an exclusion zone
- Soft barricade installed with flashing lights for visibility during dark hours.
- Goal Post installed and signage provided as an indication of the OHL in the area
- Protection requirements for OHL must be provided as per type of OHL ratings (LV, MV, HV & EHV) in accordance with the local Electricity Authority regulations.
- Machinery with the height of more than 5 meters (including height/length of extended arm/boom/jib) shall be not be allowed within 6 meters' distance both side of OHL.
