Lesson Learned No. 39

Operative working at height without fall protection

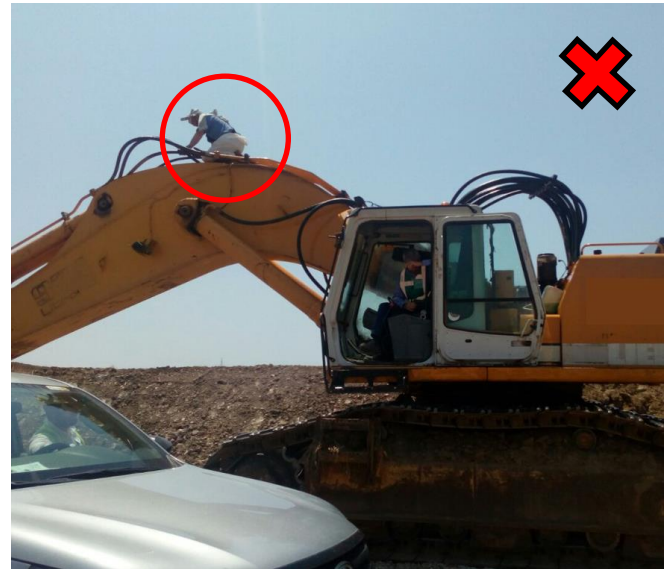
The activity required repair works to be carried out on top of the extendable boom. The boom was lowered as close to the ground as possible, but no safe work platform was provided. The height from the top of the boom to ground level was approximately 3.5 m.

The individual asked the excavator operator to switch off the engine and engage the safety lever (hydraulic knock-out). The mechanic then climbed up the excavator boom to reach the area where the hoses were located. The individual was not wearing fall arrest equipment at the time of the intervention.

Fig 1. Recreation of incident

- Failure to act or intervene from work team
- Improper risk perception
- Safe platforms or work to be undertaken from the ground level (eliminate need for Working at Height)
- Working at heights safety harness anchored to a safe point must be worn at all the times.

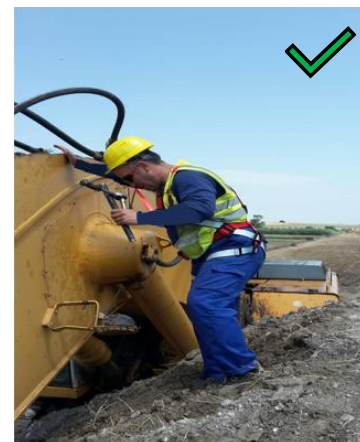
Fig 2. Correct method eliminating working at height
