Safety Alert

RETROFITTED MINI-VANS/BUSSES

Country: *AZERBAIJAN - Russia, Central Asia*

Type of Activity: *Transport - Land*

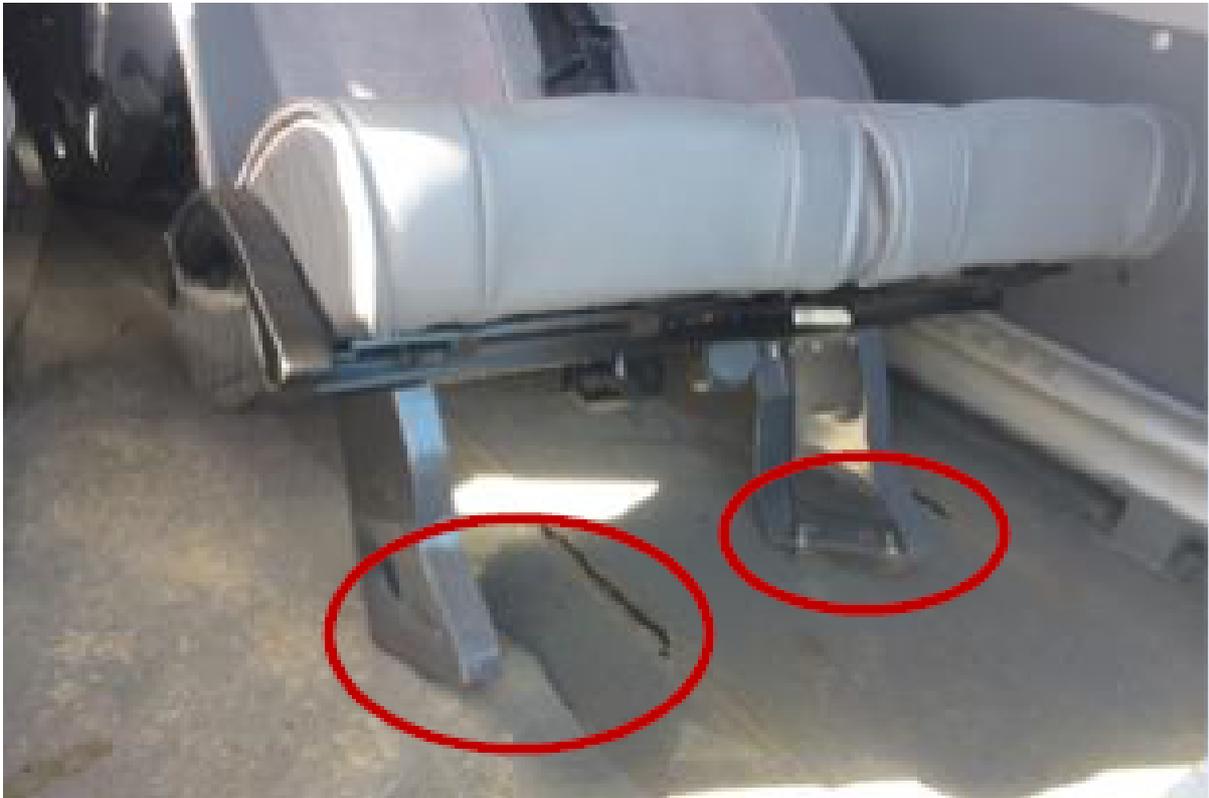
Figure 1: Inadequate seat anchorage bolts with welded square plate

Where the seat anchoring is inadequate, there is a potential risk that in the event of a collision, the seats could pull from the floor and pile forward, crushing the occupants.

1. Verify through inspection the type of seat anchorage bolts used. Seat anchorage bolts where “square plates” (Figure 1) are welded to the bolts might be inadequate in holding the seat in its position in the event of lateral force being applied (e.g. during collision). Only use appropriate, fit for purpose bolts (e.g. made out of one piece) to robustly secure the seat.

3. Where issues with inadequate seat anchorage bolts are identified, stop using these vehicles. Where issues with the inadequate anchoring of the supporting rails and rail supporting beams are identified, adopt appropriate risk management controls (e.g. operate the vehicle at lower speed). Prioritise change out of vehicles in favour of original and purpose built Mini-Vans/Busses (e.g. purpose built for the intended use of passenger transportation and supplied directly from the vehicle manufacturer’s production line).
