HSE Alert No. 01

PROPERTY DAMAGE - 200mm dia. Waterline Damage

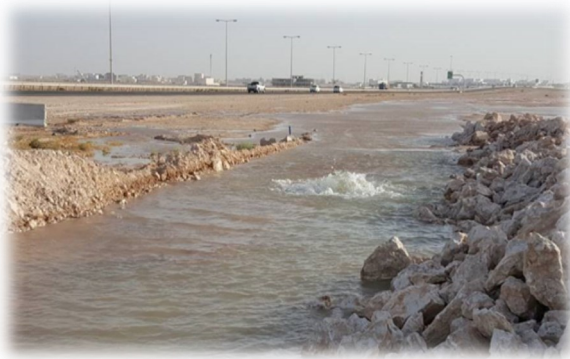
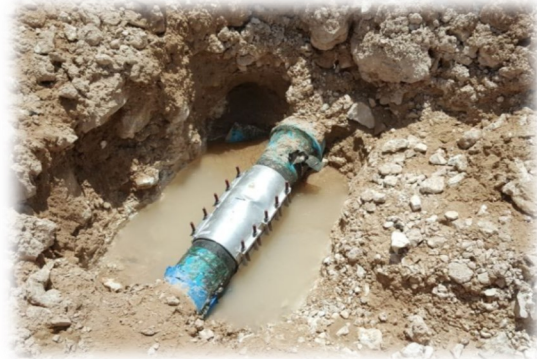
At about 05:30 a.m. on 21st of June 2017, a property damage incident occurred where a 200mm dia. potable waterline that belongs to local Water Authority, was damaged during excavation undertaken by the subcontractor.

The incident occurred when operator of excavator attached with rock breaker was assigned to carry out excavation for under pass road construction, upon completing approximately 1-meter depth of excavation, the excavator operator observed water started flowing and accumulating on the excavation.

- The damaged utility was not shown / mentioned in the provided superimposed drawing where the area was marked for excavation that identify the location of clashing point.
- There's no indication (such warning tape on the top of the pipe) that there's a U/G utility.
- The excavator operator was not aware that 200mm potable waterline was present on the location which marked for excavation.

- Relevant permit from the owner of utilities shall be obtained to ensure that the relevant regulations been followed during execution of works on the vicinity of existing utilities.

- Proper coordination has to be established with the local authorities or asset owner if the activity shall be carried out within the vicinity of existing utilities, especially if the location of suspected utilities is unknown and not shown in the provided drawings.

- Identify, locate and mark the position of U/G facilities. Features such as street lighting, drainage access points, roadside cabinets and marker posts can help identify the presence of nearby services. Do not assume that utilities are not present if the features cannot be observed.

- Use cable detection equipment to confirm the exact location of the underground services that are believed to be present and check for services that may not appear on utility provider documentation.

- Dig hand excavated trial holes to confirm the exact position of the buried services.
