Subject: Wire rope incidents note

The purpose of this note is to remind you the necessary inspections and preventive measures to apply on wire ropes of all cranes and piling rigs.

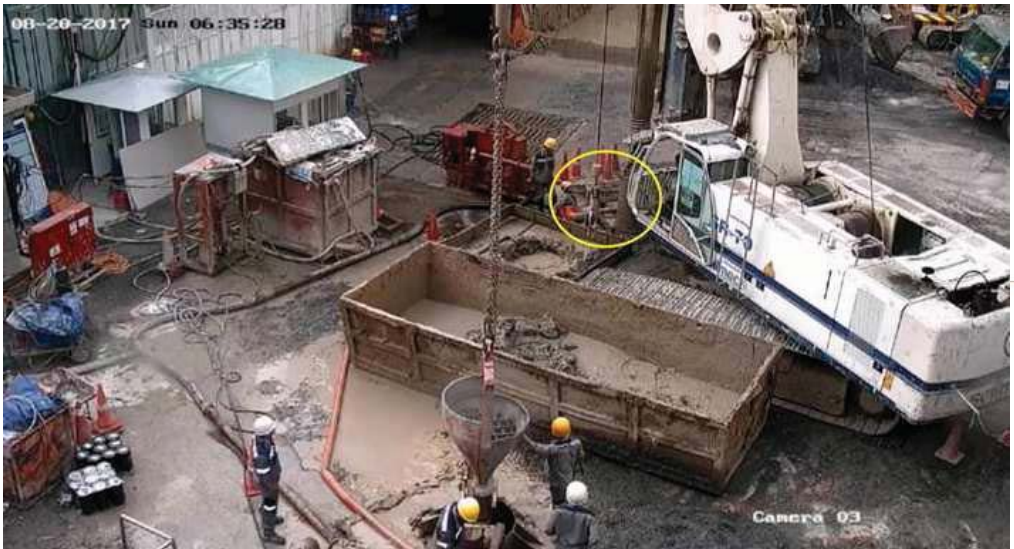
- On August 20th 2017, was performing drilling operations with a Soilmec SR70. The pile was in progress with the drilling team (Drilling operator and Kelly man).
At that time, the rig was in waiting position in order to prepare for the next pile, the bucket was suspended at 1.6m high from the ground.
The Kelly man stepped his left foot under the bucket of the machine to take a rope laying on the ground. Suddenly, the Kelly bar's cable broke down and the bucket fell down on his foot.
The emergency team immediately rescued the Injured Person (IP) and transferred him to hospital for further treatment. Four toes from his left foot were cut off and could not be reconnected with surgery.

Figure 1 - Figure 2 - Victim's position at the time of the accident

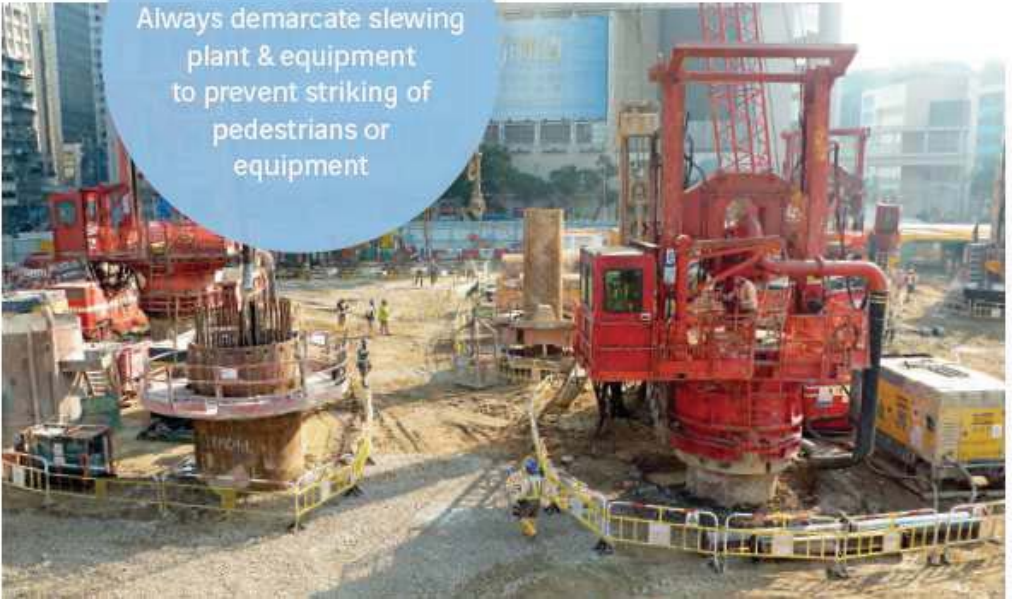
SEGROATION OF WORKING AREA

Always demarcate slewing plant & equipment to prevent striking of pedestrians or equipment

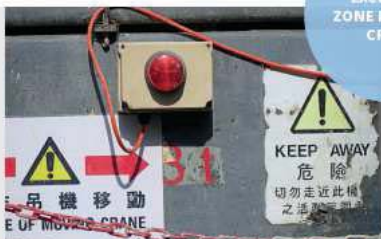
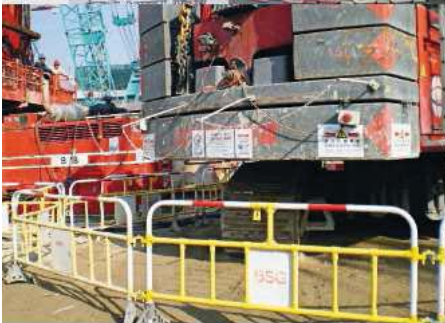
EXCLUSION ZONE NEAR THE CRANE

Flashing light for night works

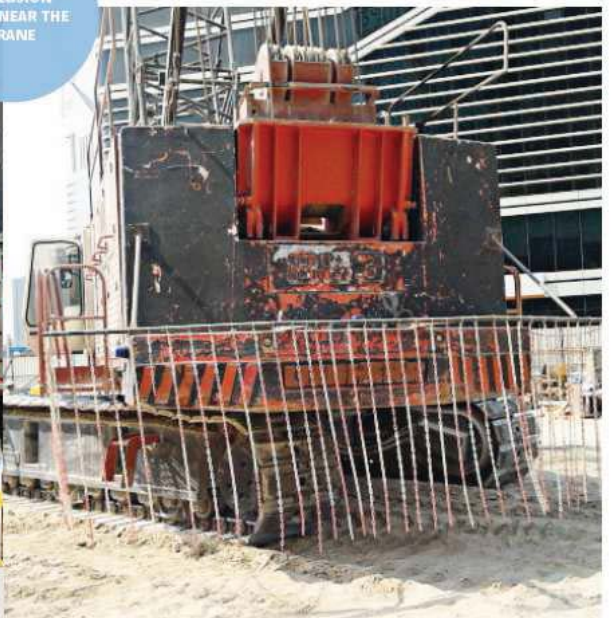
Slewing radius protection for cranes and excavator

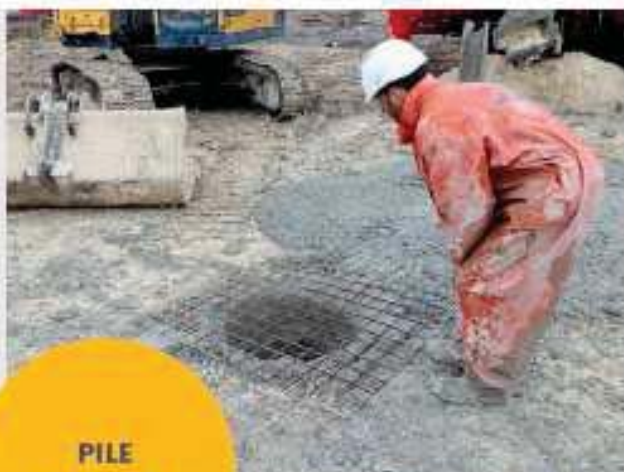
Pile covers to protect from falls into the pile shaft or excavation
