## Safety Alert

Division or Group:	HDD	Date:	10/27/17
Title:	440 Rig-Up – Unloading Equipment

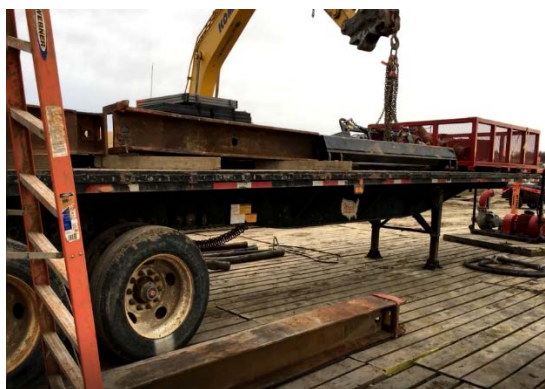
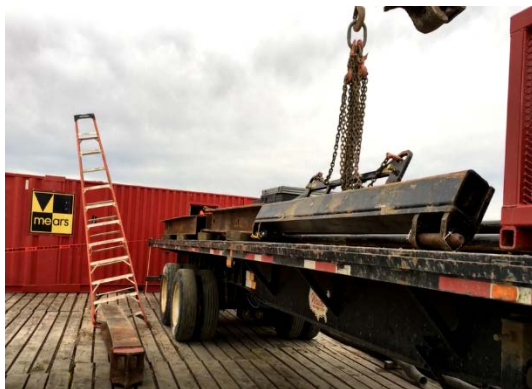
While lifting equipment from a trailer using lifting chains, the excavator operator unexpectedly lifted the load to tighten the slack without direction from the signal person. In doing so, the suspended load struck an I-beam located on the outside edge of the trailer. The I-beam was knocked off the trailer where it struck a worker who was climbing down an access ladder positioned next to the trailer. The I-beam struck the worker on the right ankle/foot resulting in a fracture.

- Excavator operator moved the load without being provided a signal to do so.
- Configuration of load on trailer.
- Securement was removed from entire load instead of only the equipment being unloaded at the time.
- Load was not assessed for stability prior to unloading.
- Ladder placement.
- Cargo Management Plan was not followed for unloading material using lifting equipment.
- Documents for Plan were not conveniently located onsite.

- Shut down all work activities, secured incident location, and notified concerned parties.
- Generate and distribute safety communication summarizing preliminary incident investigation results.
- Review with all employees on the project the following:
  - Cargo Management procedure (equipment lifting/rigging),
  - Appropriate Rig-up SWP's, and
  - Enbridge Spotter/Operator "Where Do I Stand" Training
- Adopt and implement the use of the Cargo Management Plan on all loading and unloading activities with heavy equipment. Place documents at each location.
