Facility Name: **EMAS Lewesk Champion**
Incident Date: **09th May 2016**
Shift: **Days**
Incident Type: **First Aid Case**
Incident Cause: **Human Error**
Lost Work Days: **0**

Description of Incident

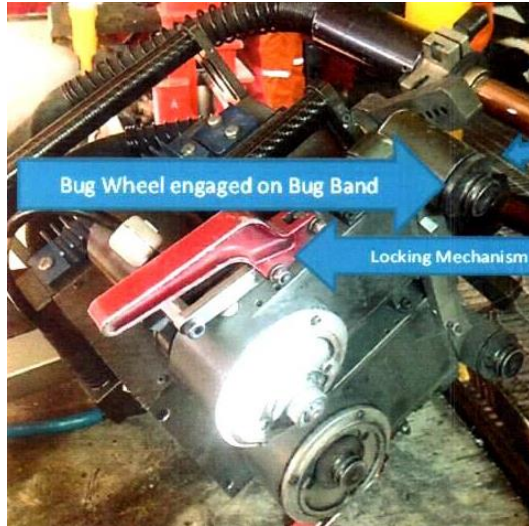
Locking mechanism on Bug, wasn't fully engaged.

Answer: Because the locking mechanism was not engaged fully.

- **All-Stop called**
- **Carry out toolbox talk**
- **Communicate Focus on Lessons Learned**

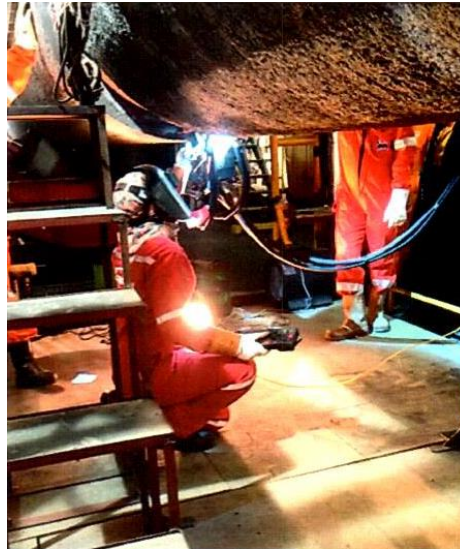
On the 9th May, 2016 approximately at 0800hrs, while performing automatic welding on the 44" pipe joint, the approximately 15kg Automatic Welding Bug detached from its Band's lowest point, slightly contacting the right hand and thigh of a welder before landing on the pipe tunnel grating. At this time the Station 2 Welder and his Welder Helper setup the Auto Welding Bug on the Pipe Band. The Bug has 2 band locks one top one bottom. The Welder locked the top and the Welder Helper locked the bottom handle on the Bug. Unfortunately the bottom lock was not engaged properly which allowed the Bug to detached from the Band and fell to the grating. IP sustained bruising/contusion to upper right thigh

Position of welder when Bug detached

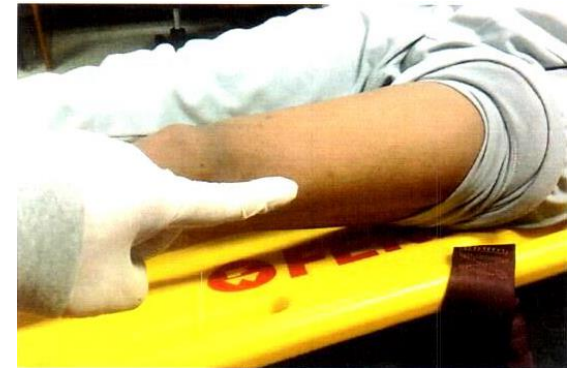
IP thigh after contact with Bug
