Safety Alert

Alert No.: HO106

Posting Date: 8/24/2017

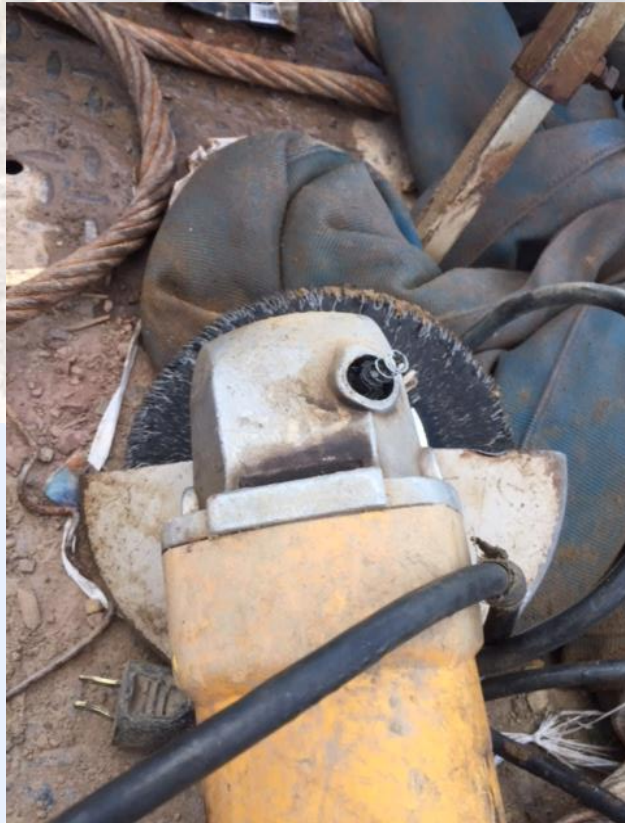
The investigation revealed that the locking mechanism used to change and remove different types of wheels (Buffing, Grinding, Stones etc.) had fallen out of the head of the grinder, the locking mechanism was locked in place as to remove the wheel. When the employee pulled the grinder back the button fell out, the pin inside locked causing the forward motion of the wheel to spin loose and come off the grinder.

The grinder was removed from service, inspection of all grinders site wide was performed. Several grinders were removed from service which illustrated concerns of failure around the locking mechanism from wear and tear.
