Brief Description of the Incident

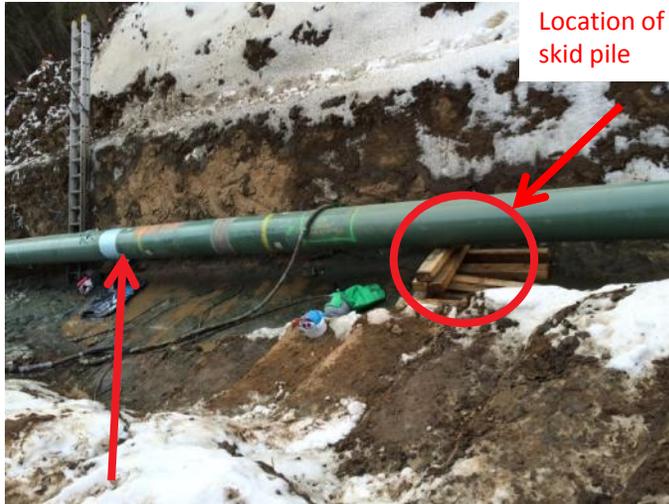
- A coating crew was in the process of preheating a upstream weld. An adjacent crew removed a skid pile roughly 30 m away. This caused the pipe to shift, pinning the worker against the excavation wall.

Location of injured coating crew member

- **Failure to secure:** A significant section of pipe was left unsupported when the skid pile was removed
- **Failure to identify hazard:** The overbend that was present created a stored energy hazard that the crews did not recognize.

- **Improper attempt to save time:** Skid pile was removed by backfill crew in prep for backfill before coaters were finished with remaining weld.
- **Lack of knowledge:** Crew members failed to recognize that the removal of the skid would cause the pipe to shift.

1. Skid pile building and pipe securement are critical tasks. These tasks should be assigned to competent workers that have sufficient experience.
2. Stored energy hazards can be challenging to identify. Crew members should be coached so that they are not overlooked.
3. A crucial aspect of planning for safe production must include understanding and communicating how crews will impact one another through adjacent work activities.
