Safety Alert: Fire in Burnley PQT yard

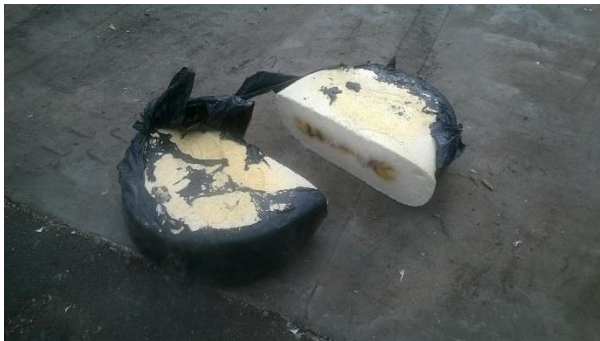
A significant fire occurred recently at our PQT facility in Burnley. The fire caused damage to a number of shipping containers that were stored in the yard area. A root cause investigation has established that the cause of the fire was an exothermic reaction of Polyurethane foam, this transferred heat to a nearby wooden crate containing waste Polypropylene causing it to ignite. The fire quickly spread to the nearby containers. Fortunately, emergency procedures were correctly followed and the Fire Services were notified, they attended site and managed to extinguish the fire soon after arrival.

Section of PU foam, smouldering following cutting.

- Only trained and competent personnel should undertake PU foam applications and disposal of foam waste.
- PU foam waste should be treated with care due to the potential fire risk and waste foam should always be disposed off in designated areas.
- Housekeeping should always be maintained to a high standard, combustible materials should be kept clear of the work area.
- Dry powder/water fire extinguishers should always be available in the work area when working with PU foam.

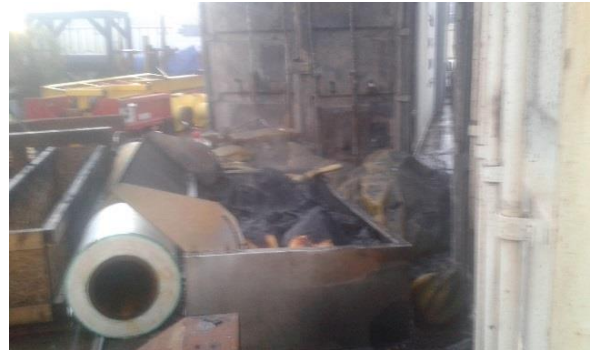
Location of quench bath that ignited nearby waste.
