Safety Alert

End Facing Attachment

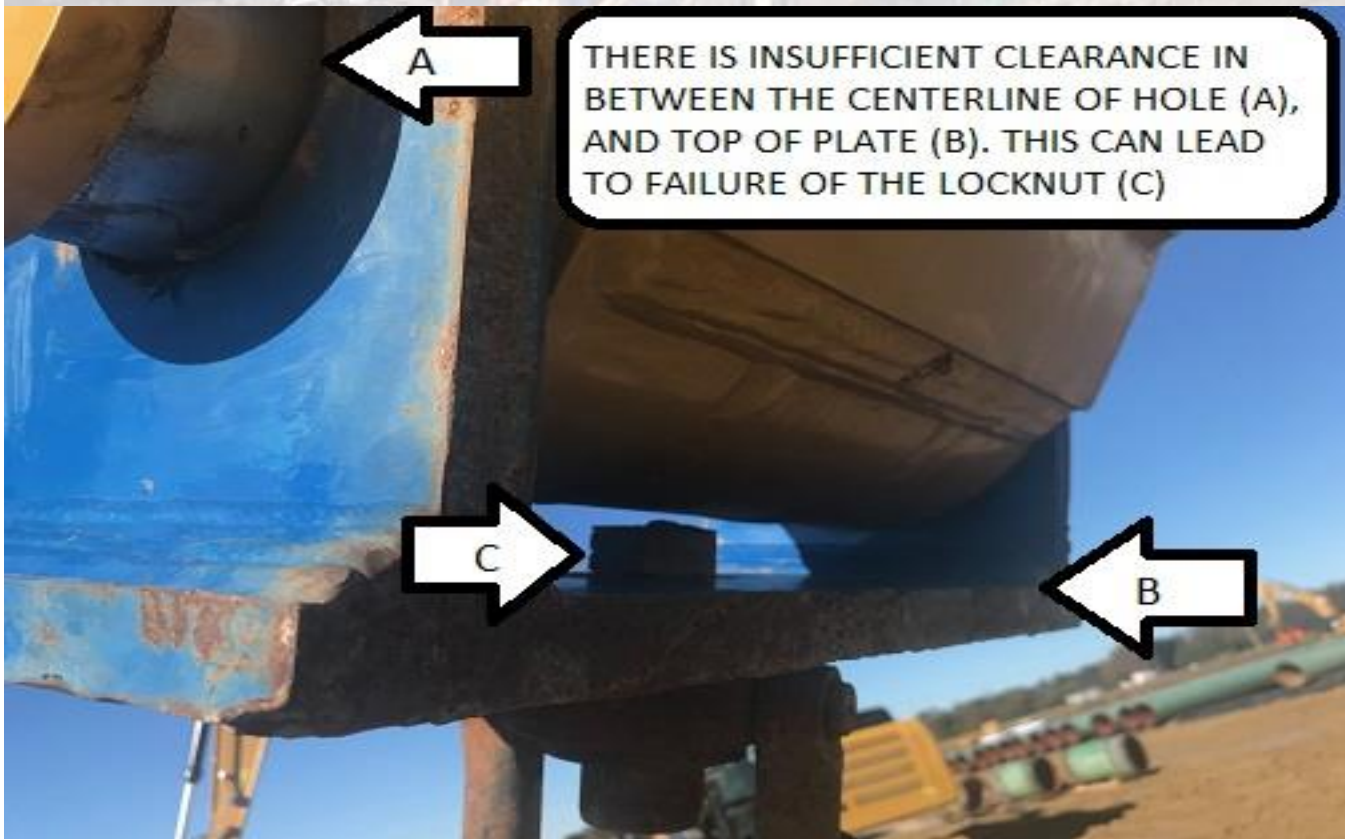
THERE IS NOT ENOUGH CLEARANCE FROM THE HOLE CENTER TO THE TOP OF THE PLATE THAT THE RIGGING ATTACHES. IN ADDITION THIS LACK OF CLEARANCE HAS CAUSED A LOCK NUT TO BE USED IN LIEU OF THE CORRECT MACHINE NUT. THE THINNER LOCKING NUT STILL CONTACTED CATERPILLAR EXCAVATORS DUE TO THE FACT THE DIMENSION FOR THE END OF THE STICK TO THE CENTER OF THE PIN HOLE IS GREATER THEN ON OTHER EXCAVATORS. THIS "BOTTOMING OUT" ON THE LOCK NUT DAMAGES THE NUT CAUSING POTENTIAL FAILURE AND DROPPING OF THE END FACER.

SWIVEL STOPPED BY LOCKNUT

A THREE INCH RISER WAS INSTALLED ON TOP OF THE ORIGINAL SWIVEL PLATE TO ALLOW FOR SUFFICIENT CLEARANCE AND A PROPER MACHINE NUT. THERE IS NO POSSIBLE POTENTIAL FROM CONTACT OF THE BOLT OR NUT USING THIS DESIGN. AS AN ADDED PRECAUTION THE NUT IS TACK WELDED.

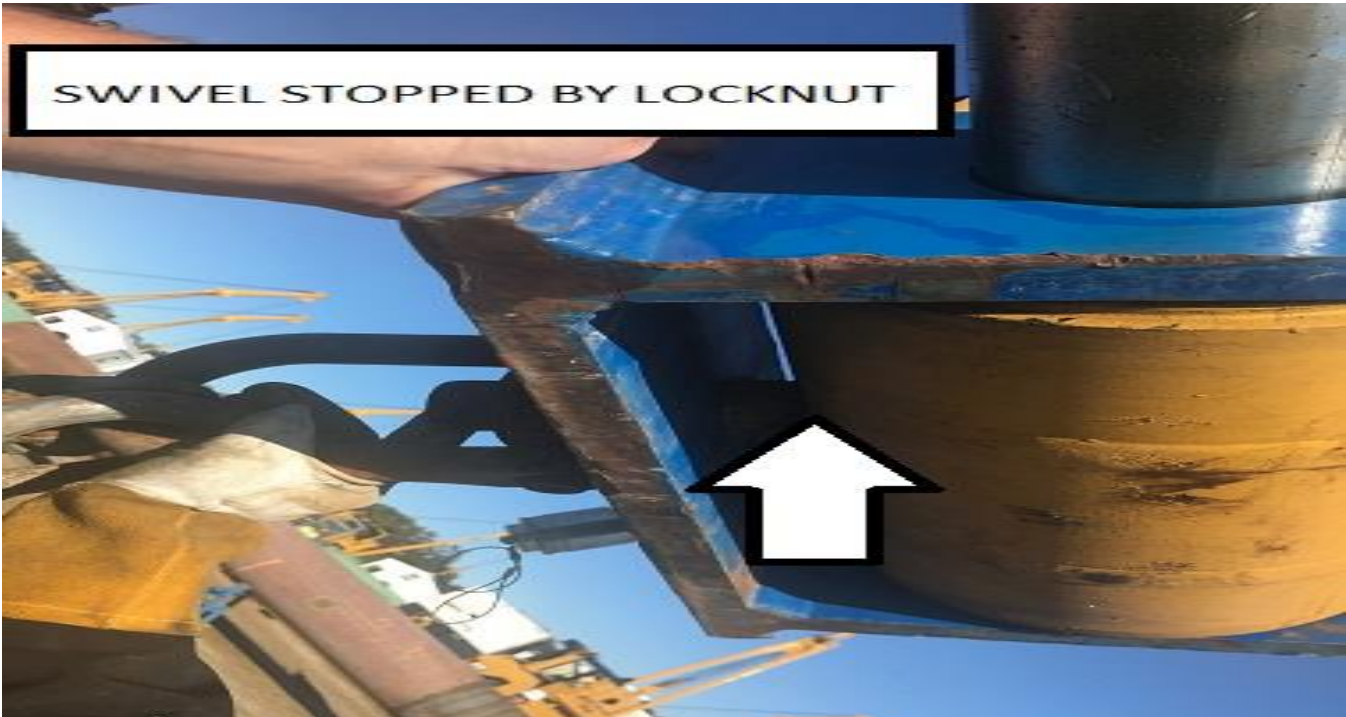
CONTACT

LOCKNUT

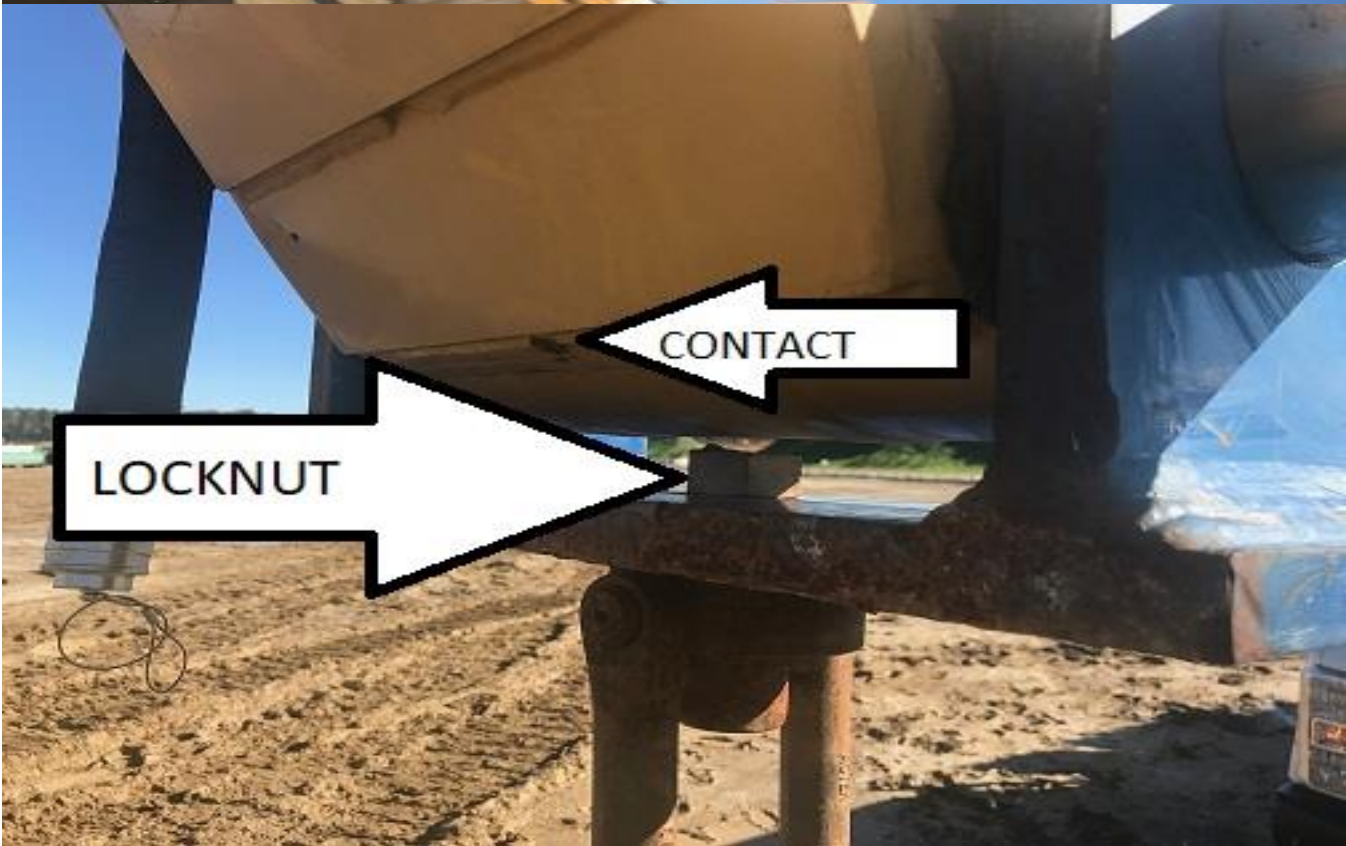
THREE INCH RISER ADDED TO TOP PLATE OF SWIVEL WITH CLEARANCE HOLE TO ACCESS CORRECT NUT WITH A SOCKET.

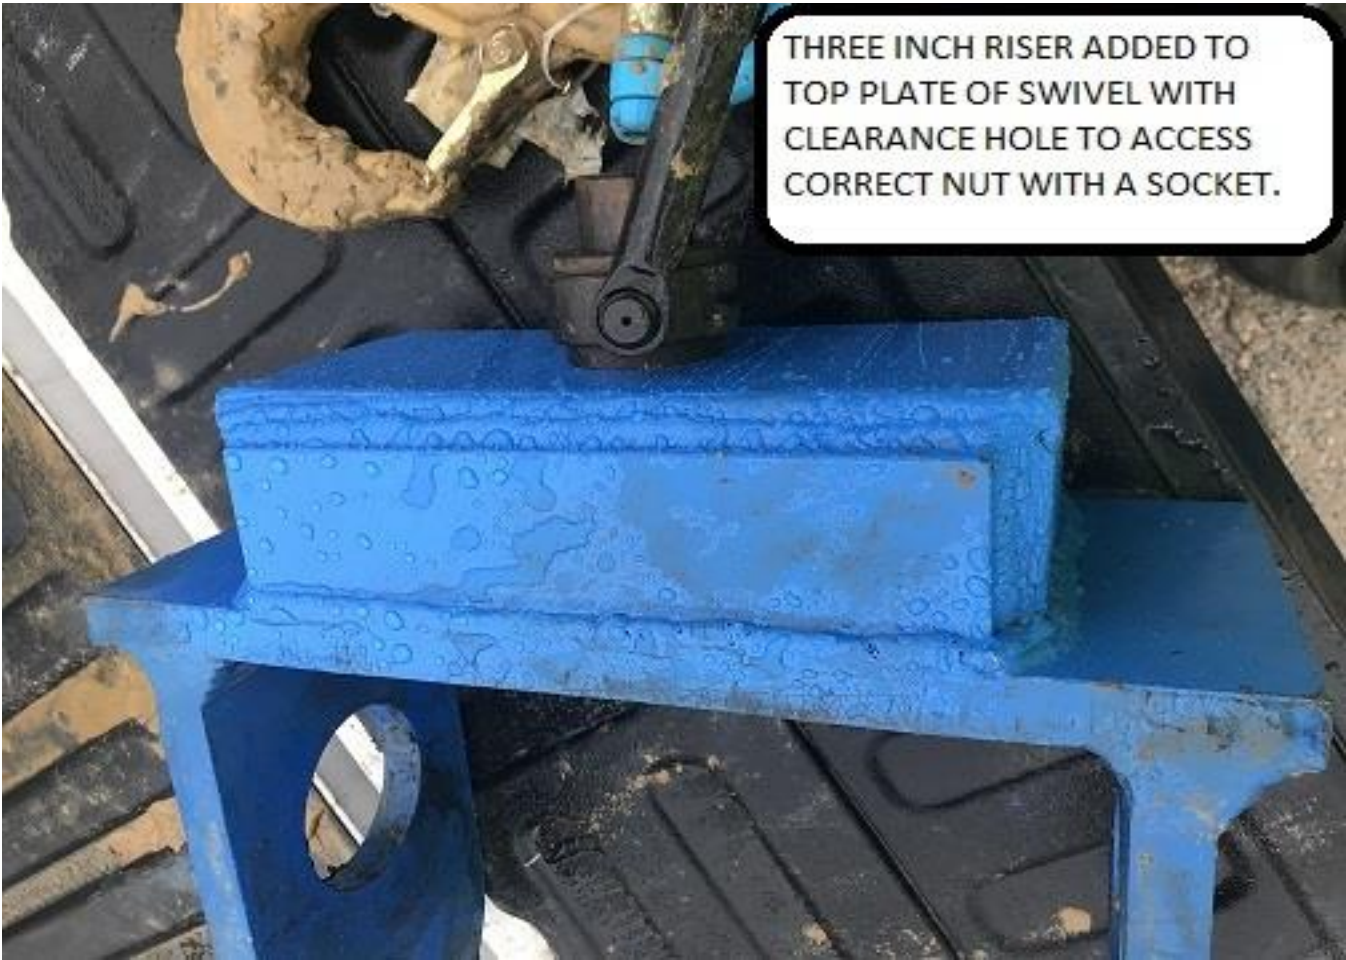
VIEW OF THROUGH HOLE TO ALLOW ACCESS TO CORRECT NUT WITH SOCKET.
