## HSSE Alert

REF: GHSSE/IN-AL/2018-31

### COLLAPSED TRENCH WALL RESULTING IN A FATALITY

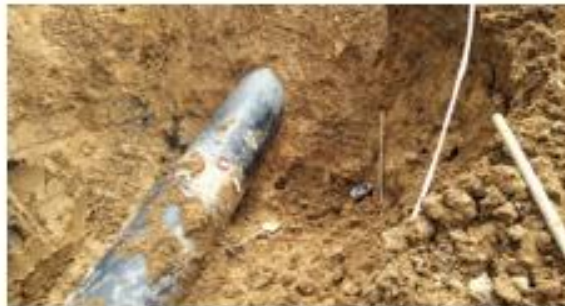
Figure 1: Location of the incident

In October 2018, two contractors were in the midst of an underground pipeline strain gauge installation activity when a 3.5 meter trench they were in suddenly collapsed. One of the workers managed to avoid the hazard but the Deceased Person (DP) was buried under the soil. DP was unconscious when the team freed him from the collapsed trench and was pronounced dead at the hospital.

1. Communicate PETRONAS Excavation Procedure on adequacy of cave-in protection and monitor implementation.
2. Observe soil condition during rainy season and take precautions accordingly.
3. Enhance supervision at site by PETRONAS Representative.
4. Enforce compliance to HSE Requirements and Z&T Rules.
5. Intervene and exercise Stop Work if any unsafe conditions are observed.
