SPIECAPAG

2018 IPLOCA Health and Safety Awards

SAFETY TAG FOR LIFTING PARTS

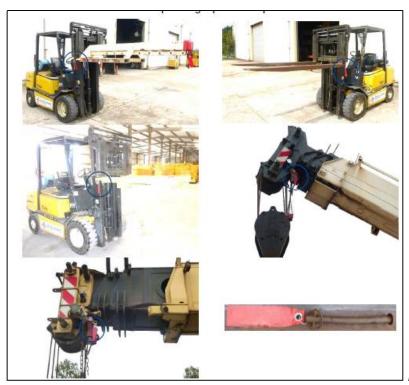
Forklift and crane equipped

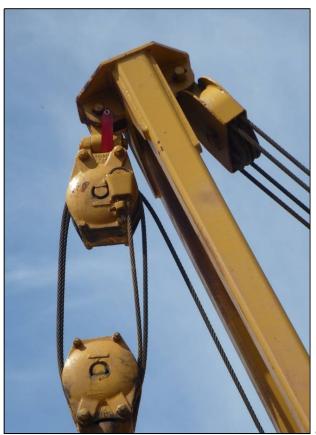
Sideboom equipped
