SAFETY Alert

N° 07/2021 Date: July 2021

OBJECT: DAMAGE TO OHPLs DURING TRANSPORT

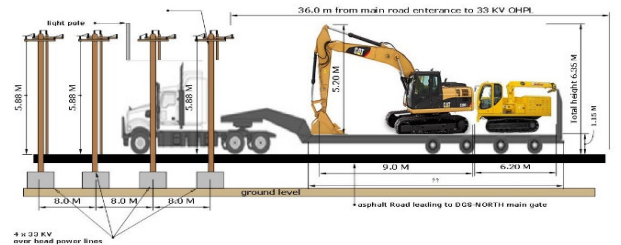
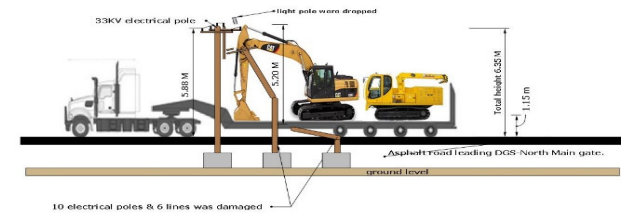
Sicim subcontractor decided to transfer Caterpillar excavator 324E and a paywelder to site, both equipment were loaded on same lowbed trailer.

At 05:45 am the lowbed trailer arrived to the public asphalt road leading to main access gate in order to reach the construction site. While passing under existing overhead 33 KV energized power lines, the excavator boom made contact with the overhead power lines causing cutting of 06 overhead cables and damaging 10 supporting poles.

There were no injuries as a result of this incident.

- Poor driving Safety culture: Subcontractor has no system in place to evaluate and select qualified drivers following local regulations;
- Inadequate training: no defensive driving to driver nor specific training to ensure transportation and loading are properly controlled;
- No traffic management plan: Subcontractor is not performing any pre-survey to prepare traffic plan for transportation of heavy machines to site; this plan should identify the way of transportation, risks of road and preventive actions.

- Subcontractor to put in place pre-selection system for drivers and operators;
- Periodic trainings to be delivered to drivers and supervisors involved in transportation and Public Roads activities;
- Company to evaluate installation of goal posts on Public Roads to protect overhead lines passing over asphalt roads of the field;
- Pre-survey of the route and traffic plan to be prepared and communicated to driver's prior transportation of heavy machines;
- Development of a safety alert and sharing with the entire workforce and subcontractors;
- Ensure adequate auditing of Subcontractor activities to prevent future failures.
