LESSON LEARNT

N° 11/2019 Date: November 2019

OBJECT REINFORCEMENT OF MANUAL WELDING TENTS

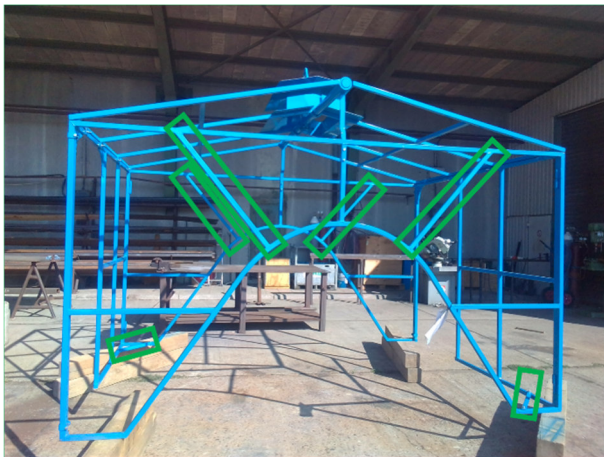
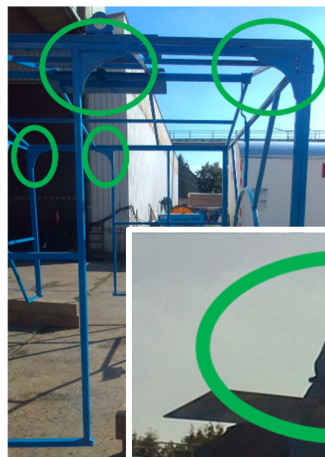
Damage detected on site

The welding tents are structures specifically designed and built for the automatic and manual welding phase of the pipelines in order to protect the weld pool from the elements, avoiding the appearance of defects to be repaired in the welds. Numerous episodes of damage, deformation and fragile breakage of these structures have been found in several SICIM construction sites during their operational life, especially during their positioning for welding and during the movement of the paywelder. In a construction site, therefore, modifications were planned and implemented on the manual welding tent in order to improve their structural solidity. The lifting point for attachment to the arm of the paywelder has also been modified, as its failure may lead to a serious lifting risk.
