I HOPE THIS SUCKS!

BASIC VACLIFT ANATOMY

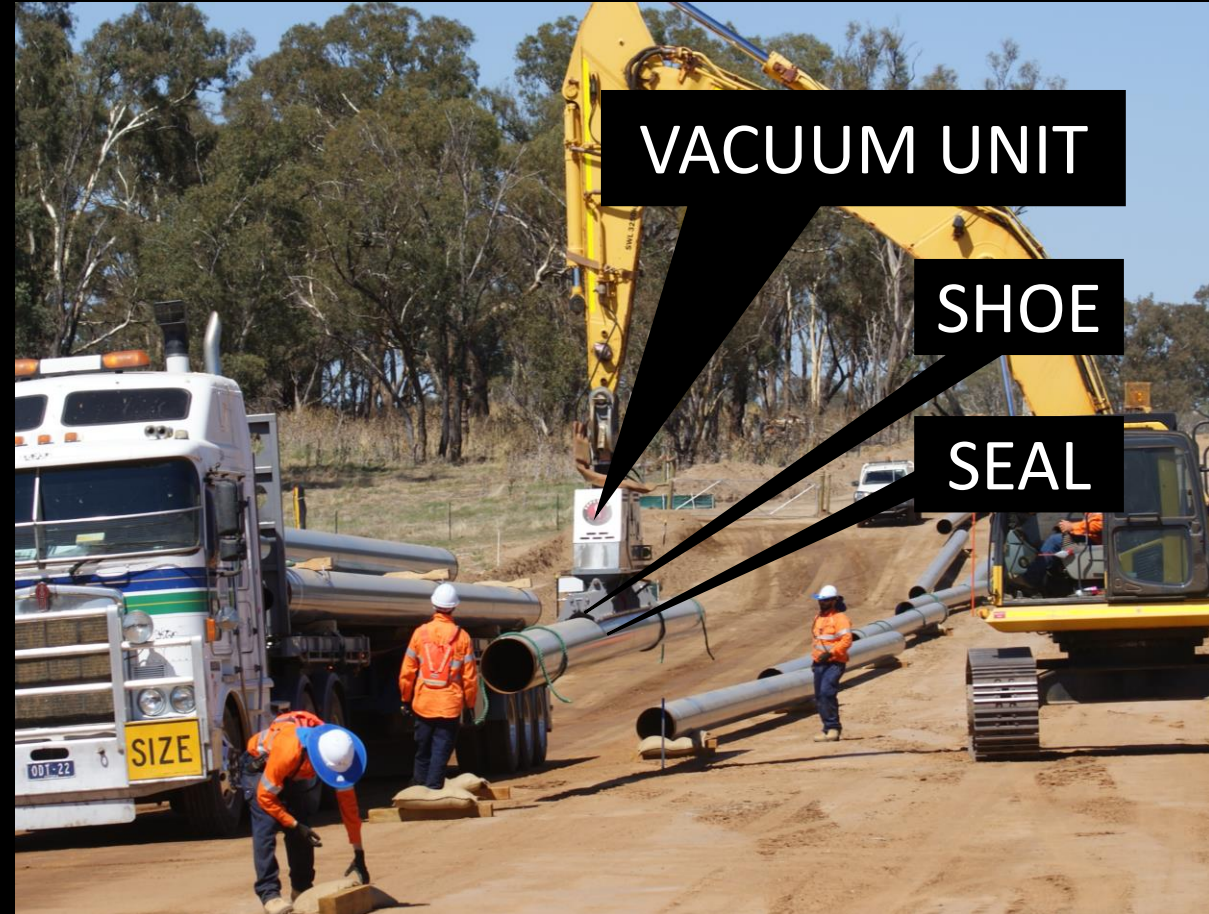
HITCH MOUNTED VACUUM
UNIT WITH SINGLE SHOE

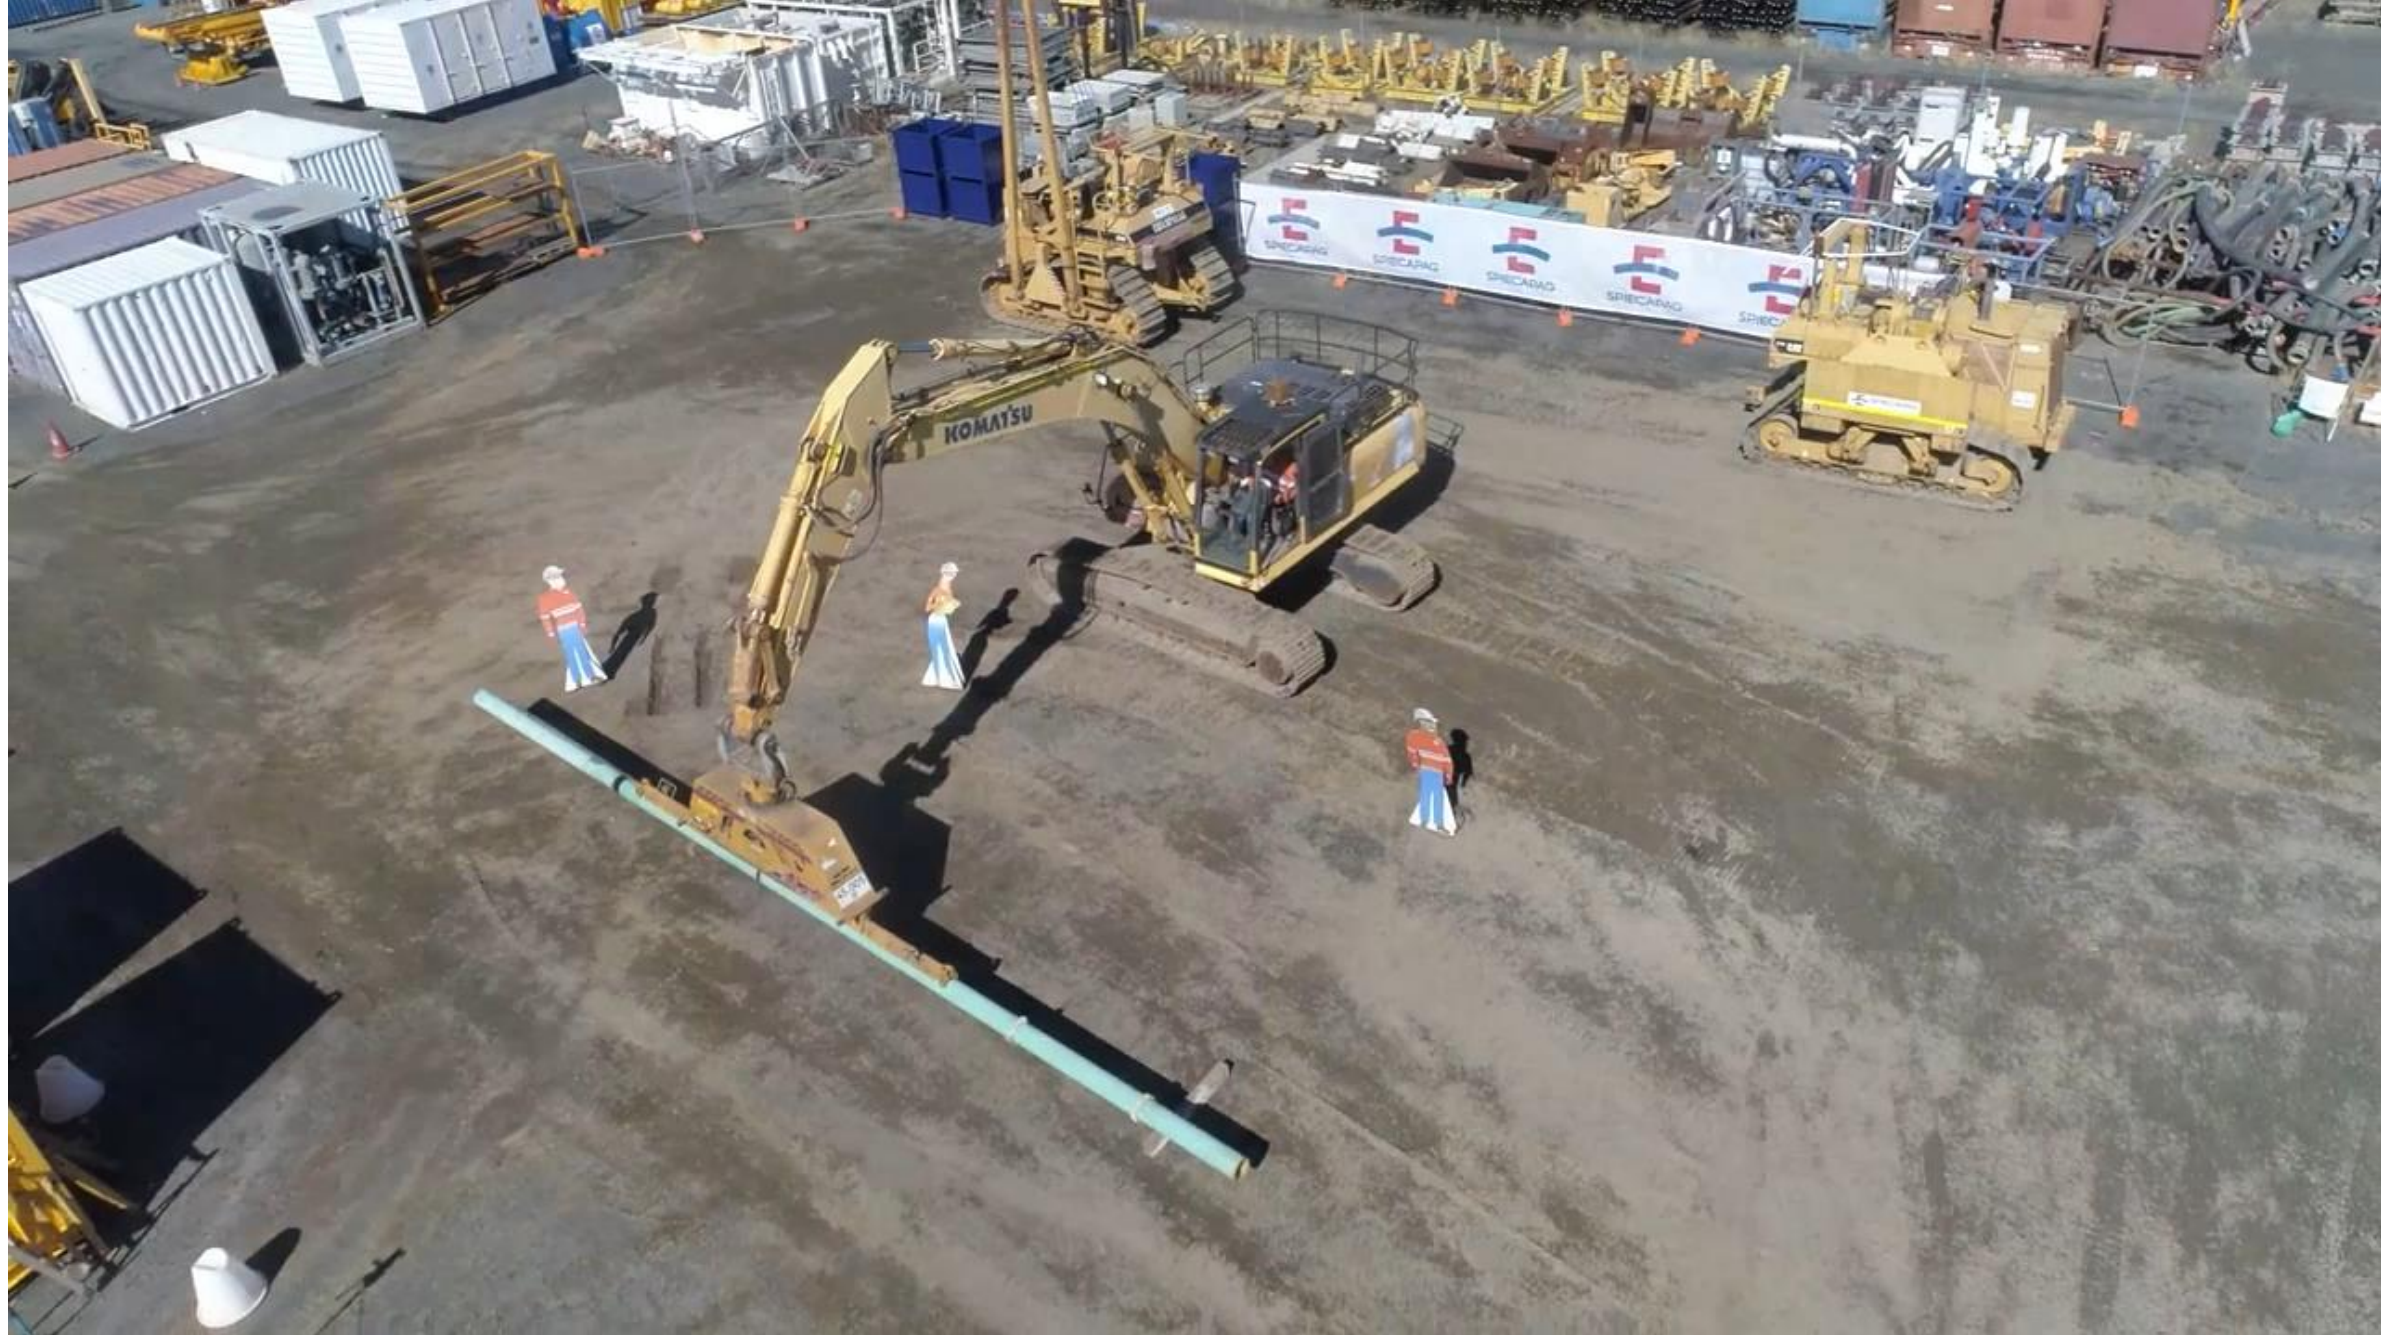
PIPE DROP CONDUCTED UNDER TEST CONDITIONS

* VAC-LIFT MAINTAINED SUCTION AND LIFT ON PIPE DURING TRIAL, THEREFORE PIPE WAS MANUALLY DROPPED TO REPRESENT INCIDENT

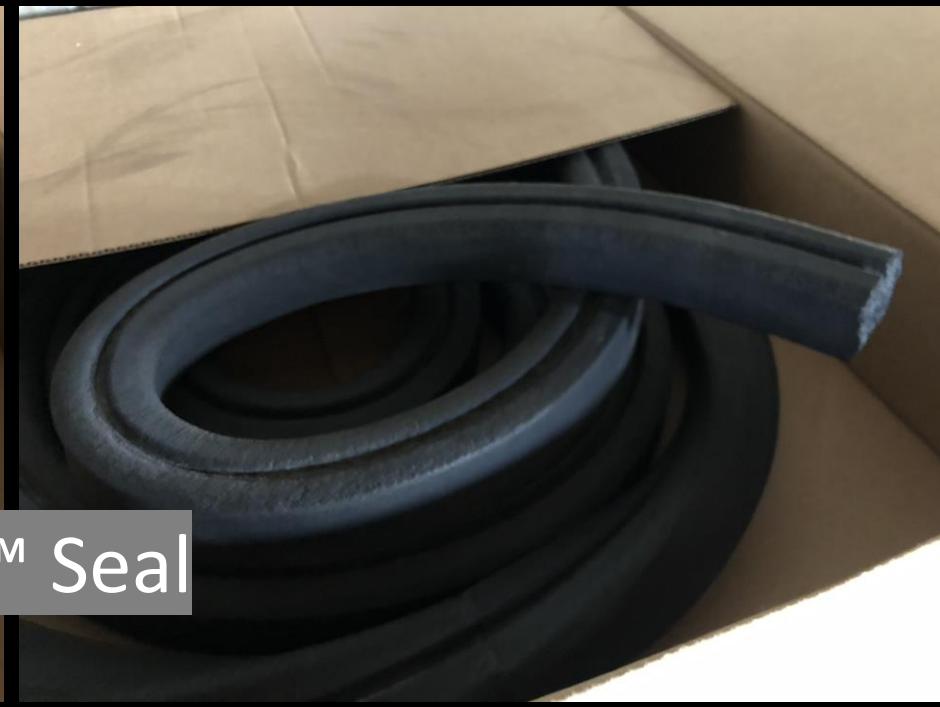
Vacuworx 50mm x 50mm Black Seal

- single-piece extrusion to Vacuworx specifications
- Closed cell rubber – does not absorb water or other fluids
- High UV resistance
- Typically, 6000 to 8000 lifts.

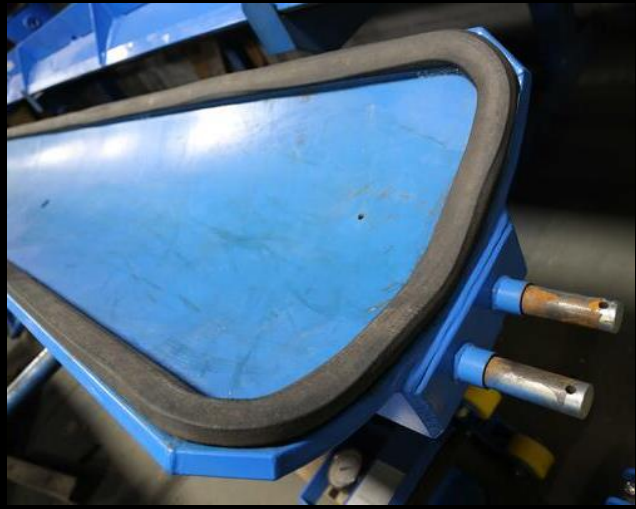
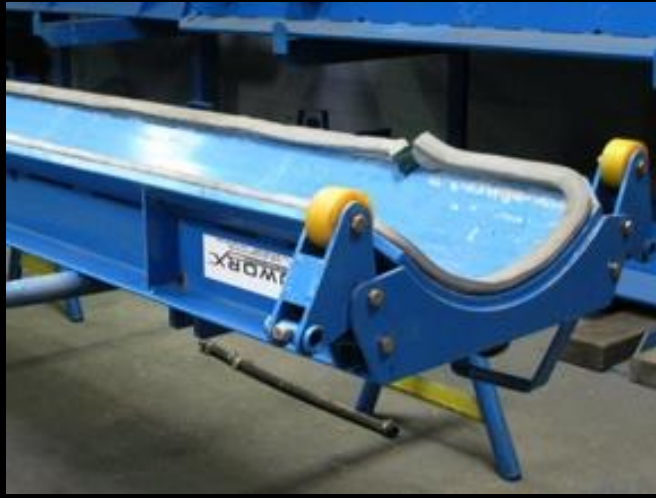
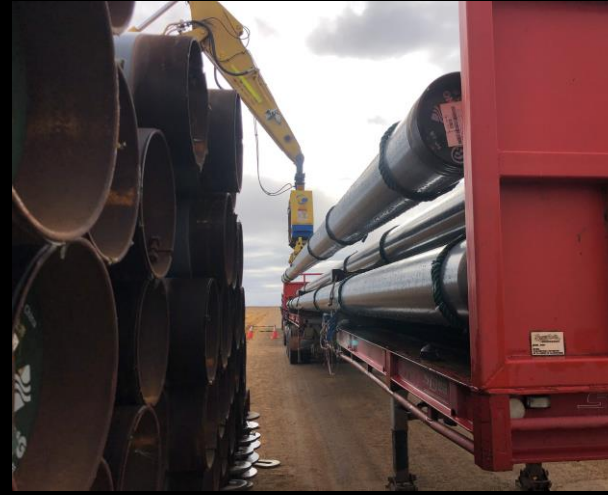
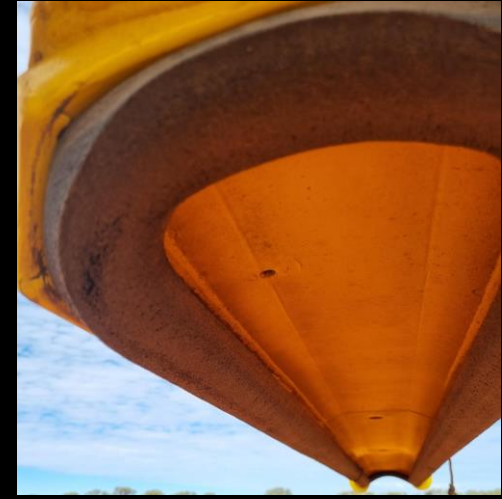
Vacuworx H-Lok Performance

- NGL project 323mm pipe using MC5 / RPM12 Vacuworx system
- Over 12,000 lifts with no loss of vacuum during pre-start test lifts
- Approximately 4 cents per lift in seal cost.
