# SAFETY Alert

**PREPARED BY: Corporate QHSE Dept.**

N° 05/2023 Date: May 2023

**OBJECT: GRINDING DISK RUPTURE**

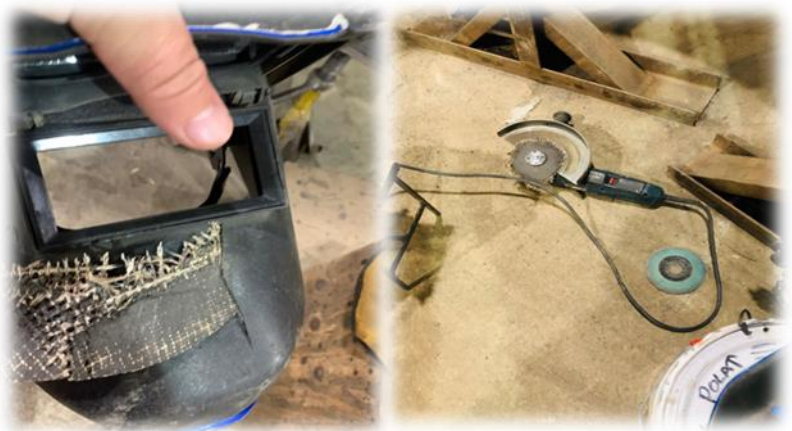
At the fabrication shop a manual welder was involved in welding activities of 24" pipes (35mm thickness): after the 1st root of the weld, the welder started to clean the weld with grinding machine using a cutting disc for grinding. While cleaning the weld, the cutting disc fell apart into fragments. As a result, grinding disk fragments penetrated through the welding mask and slightly scratched welder's nose and eyes. IP was evacuated to nearest hospital for further examinations. From incident investigation it resulted that, due to operational needs, the grinding machine guard was tampered and modified to accommodate a bigger (230mm) cutting disk than the approved dimension disk (125mm).

- Inadequate risk perception / risk underestimated: despite during visual inspection of the tool the disc was observed with the edges eroded - cutting disk used for grinding, the work was not stopped;
- Inadequate or missing guards or barrier: handmade protective cover installed on grinding machine to accommodate cutting disc;
- Inadequate Supervision: permanent construction and HSE supervision not assigned for the task. Foreman controlling 38 welders in two different welding workshops;
- Failure to use PPE or incorrect PPE: safety glasses not worn during grinding activities. Additionally, grinding disk fragments penetrated through the welding mask. Quality of Welding masks needs to be reassessed.

- Training to all welders, highlighting the safe work process during the welding and grinding activities and safe use of grinding machine;
- Periodical check all power hand tools to ensure tampered one are not present;
- Familiarize all site staff with incident details during the Safety stand down meeting, highlighting that cutting disk cannot be used for grinding;
- Increase number of frontline supervisors in welding shop: each shop needs to be supervised by a dedicated supervisor;
- Purchase the proper tool suitable for the specific use and ensure that no modifications are performed.
- Use the safety glasses with clear lenses under the welding mask during grinding activities and assess the quality of the utilized welding mask.
