Lesson Learned No-10

VEHICLE ROLLOVER ON TO SIDE - HIPO NEAR MISS

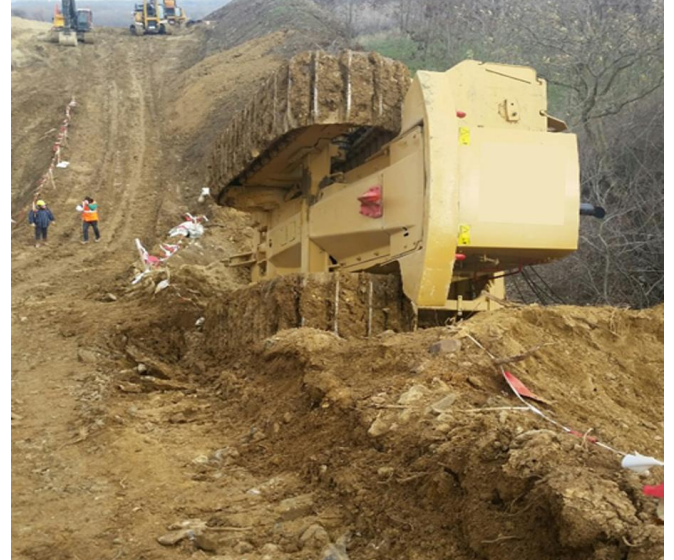
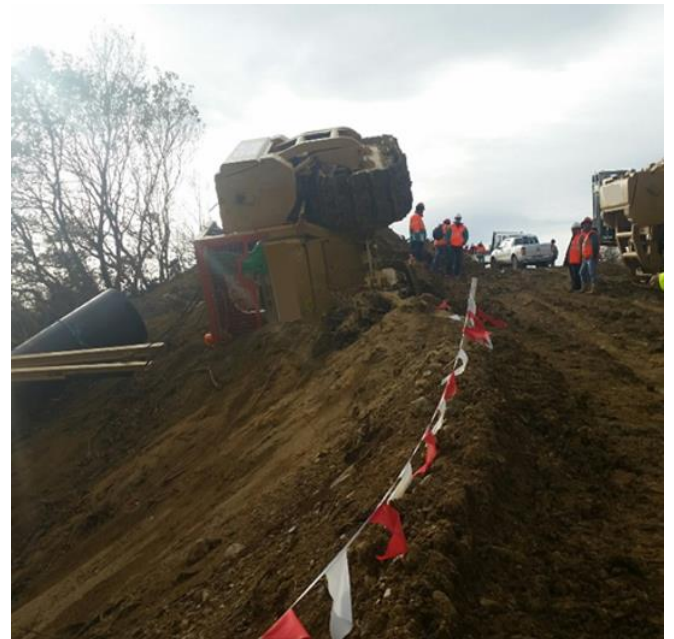
Photo:

Side-boom assigned to Tie-in crew tilted sideways into a side slope on the left side of the RoW.

The machine was passing between two stationary side-booms, involved in a tie-in activity.

Due to the available pass way being very narrow, the operator recovered the counter-weight and tracked the machine too close to the non-compacted edge of the RoW, having the load on the slope side.

The machine started to tilt sideways and the operator, trying to release the weight, started lowering the load.

He moved both hook and boom, causing the machine to become off balanced and rolled completely to its left side.

- The activity was suspended and an investigation was started.
- A stand down was organized on the following day by the Project Manager and Construction Manager with all construction Supervisors and Side-boom operators.

- Lack of planning of the activity.
- Transportation of pipe was not included on the Job Safety Analysis
- Ground conditions should be assessed prior instruction given by Supervisor
- When equipment is working on a congested area, a banksman must be use for Operator's guidance.
