UNCONTROLLED MOVEMENT OF PIPE – HIPO NEAR MISS

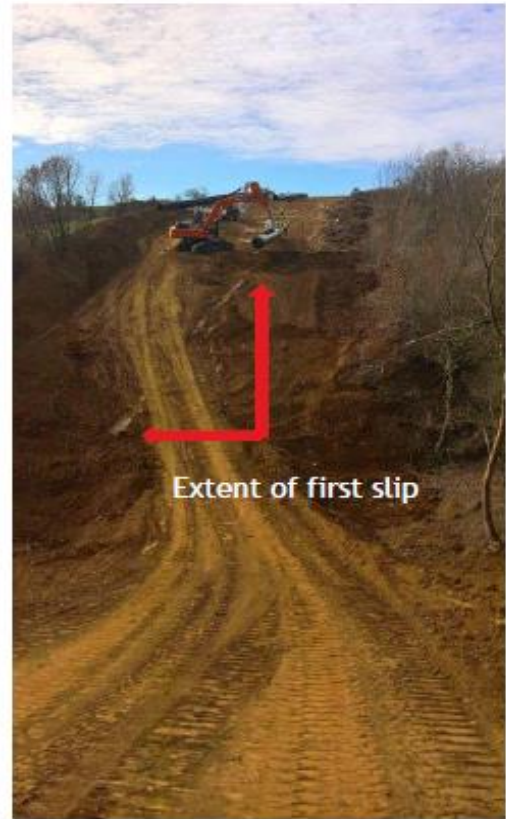
Photo

During stringing activities a pipe was placed on a skid by the operator of the vacuum lifter (the operator was a replacement operator). The operator started to draw back and the pipe slipped from the skid crotch and slowly slid towards the lower part of the slope, moving approximately 40 metres down the RoW. No workers were present in the area below the pipe.

The vacuum lifter operator decided to lift the pipe section again and to string it at an upper level of the work area. Once the pipe had been laid, the pipe slipped again from the skid, this time for a length of approximately 5 meters. Workers were all at a safe distance and nobody was hurt.

- Combination of factors: temperature (-5° C), wood skids made slippery by moisture, section of pipe made slippery by moisture, pipe not laying correctly in the center of the skid crotch, designated vacuum lifter operator last minute replacement.
- The incline of the slope was deemed not particularly steep by the supervisor the pipe had not been anchored or blocked by an earth berm on the front.
- At the time of the incident, the designated work phase supervisor was not present on location.

- Installation of an earth berm at the front lines of the already laid pipes, on both sides of the slope
- Work suspended until a review of the risk assessment and method statement had been undertaken and new control measures distributed to the stringing crew.

- Define and mark slopes with color coding and signs at the bottom and top of slopes, per international standards (i.e. normal slope, green, $\leq 7^\circ$; medium slope, yellow, $> 7^\circ < 14^\circ$; steep slope, red, $\geq 14^\circ$)
- Slopes above 11° in winter times wooden skids on steep slopes must not be utilized, berms, earth piles, spikes shall be arranged to anchor the pipes.
- Risk Assessment, Method Statement and all relevant procedures must be present and known to all concerned.
- JSA and Toolbox shall consider contingent conditions like weather conditions and absence of key persons.
- Change management procedure to be applied.
- The supervisor must be present at all times while stringing is ongoing.
