PIPELINE INDUCTION HEAT

Safety Alert: IMPP Purging Incident

Issue 2

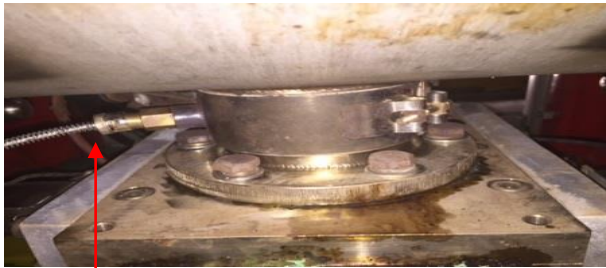
Thermocouple

Following Root Cause investigation it has been established that a thermocouple had moved from its housing and was giving an incorrect temperature reading as it was reading air temperature rather than the pipework temperature. Consequently the Polypropylene was over heated and became a liquid. When the purging process took place, the hot liquid situated behind the injection port 'plug' of hardened material and was ejected at high pressure and out into the immediate vicinity where Technicians were incorrectly positioned.

- Barriers to be placed around all IMPP equipment and only approved personnel allowed in designated zones.
- Constant monitoring of thermocouples during each shift and record results on checklists provided. Checklists have been updated to show the exact locations of the Thermocouples and record readings against HMI panel readings
- Ensure all maintenance records are completed in full.
- Updated HSEQ action request to be read & understood by Project teams
- Ensure PPE is being worn at ALL times as per risk assessment.
- **A Full Equipment Safety review is being undertaken and any further Equipment modifications will be cascaded to all project teams and Clients.**

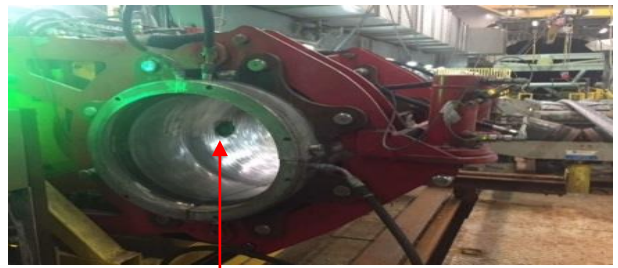
Infill tube/Ejection port

Following a short period of inactivity on an Offshore IMPP project an incident occurred during purging of the IMPP machine whereby hot molten polypropylene has ejected from the infill tube / mould and splashed onto 2 PIH Technicians causing burns to neck, arms & hands.
